La Conchita Slope Stabilization Project

Geological Study
La Conchita, Ventura County

Contract No. 3108855 (CRN 17600307169846)
Project No. 122259A

August 28, 2009

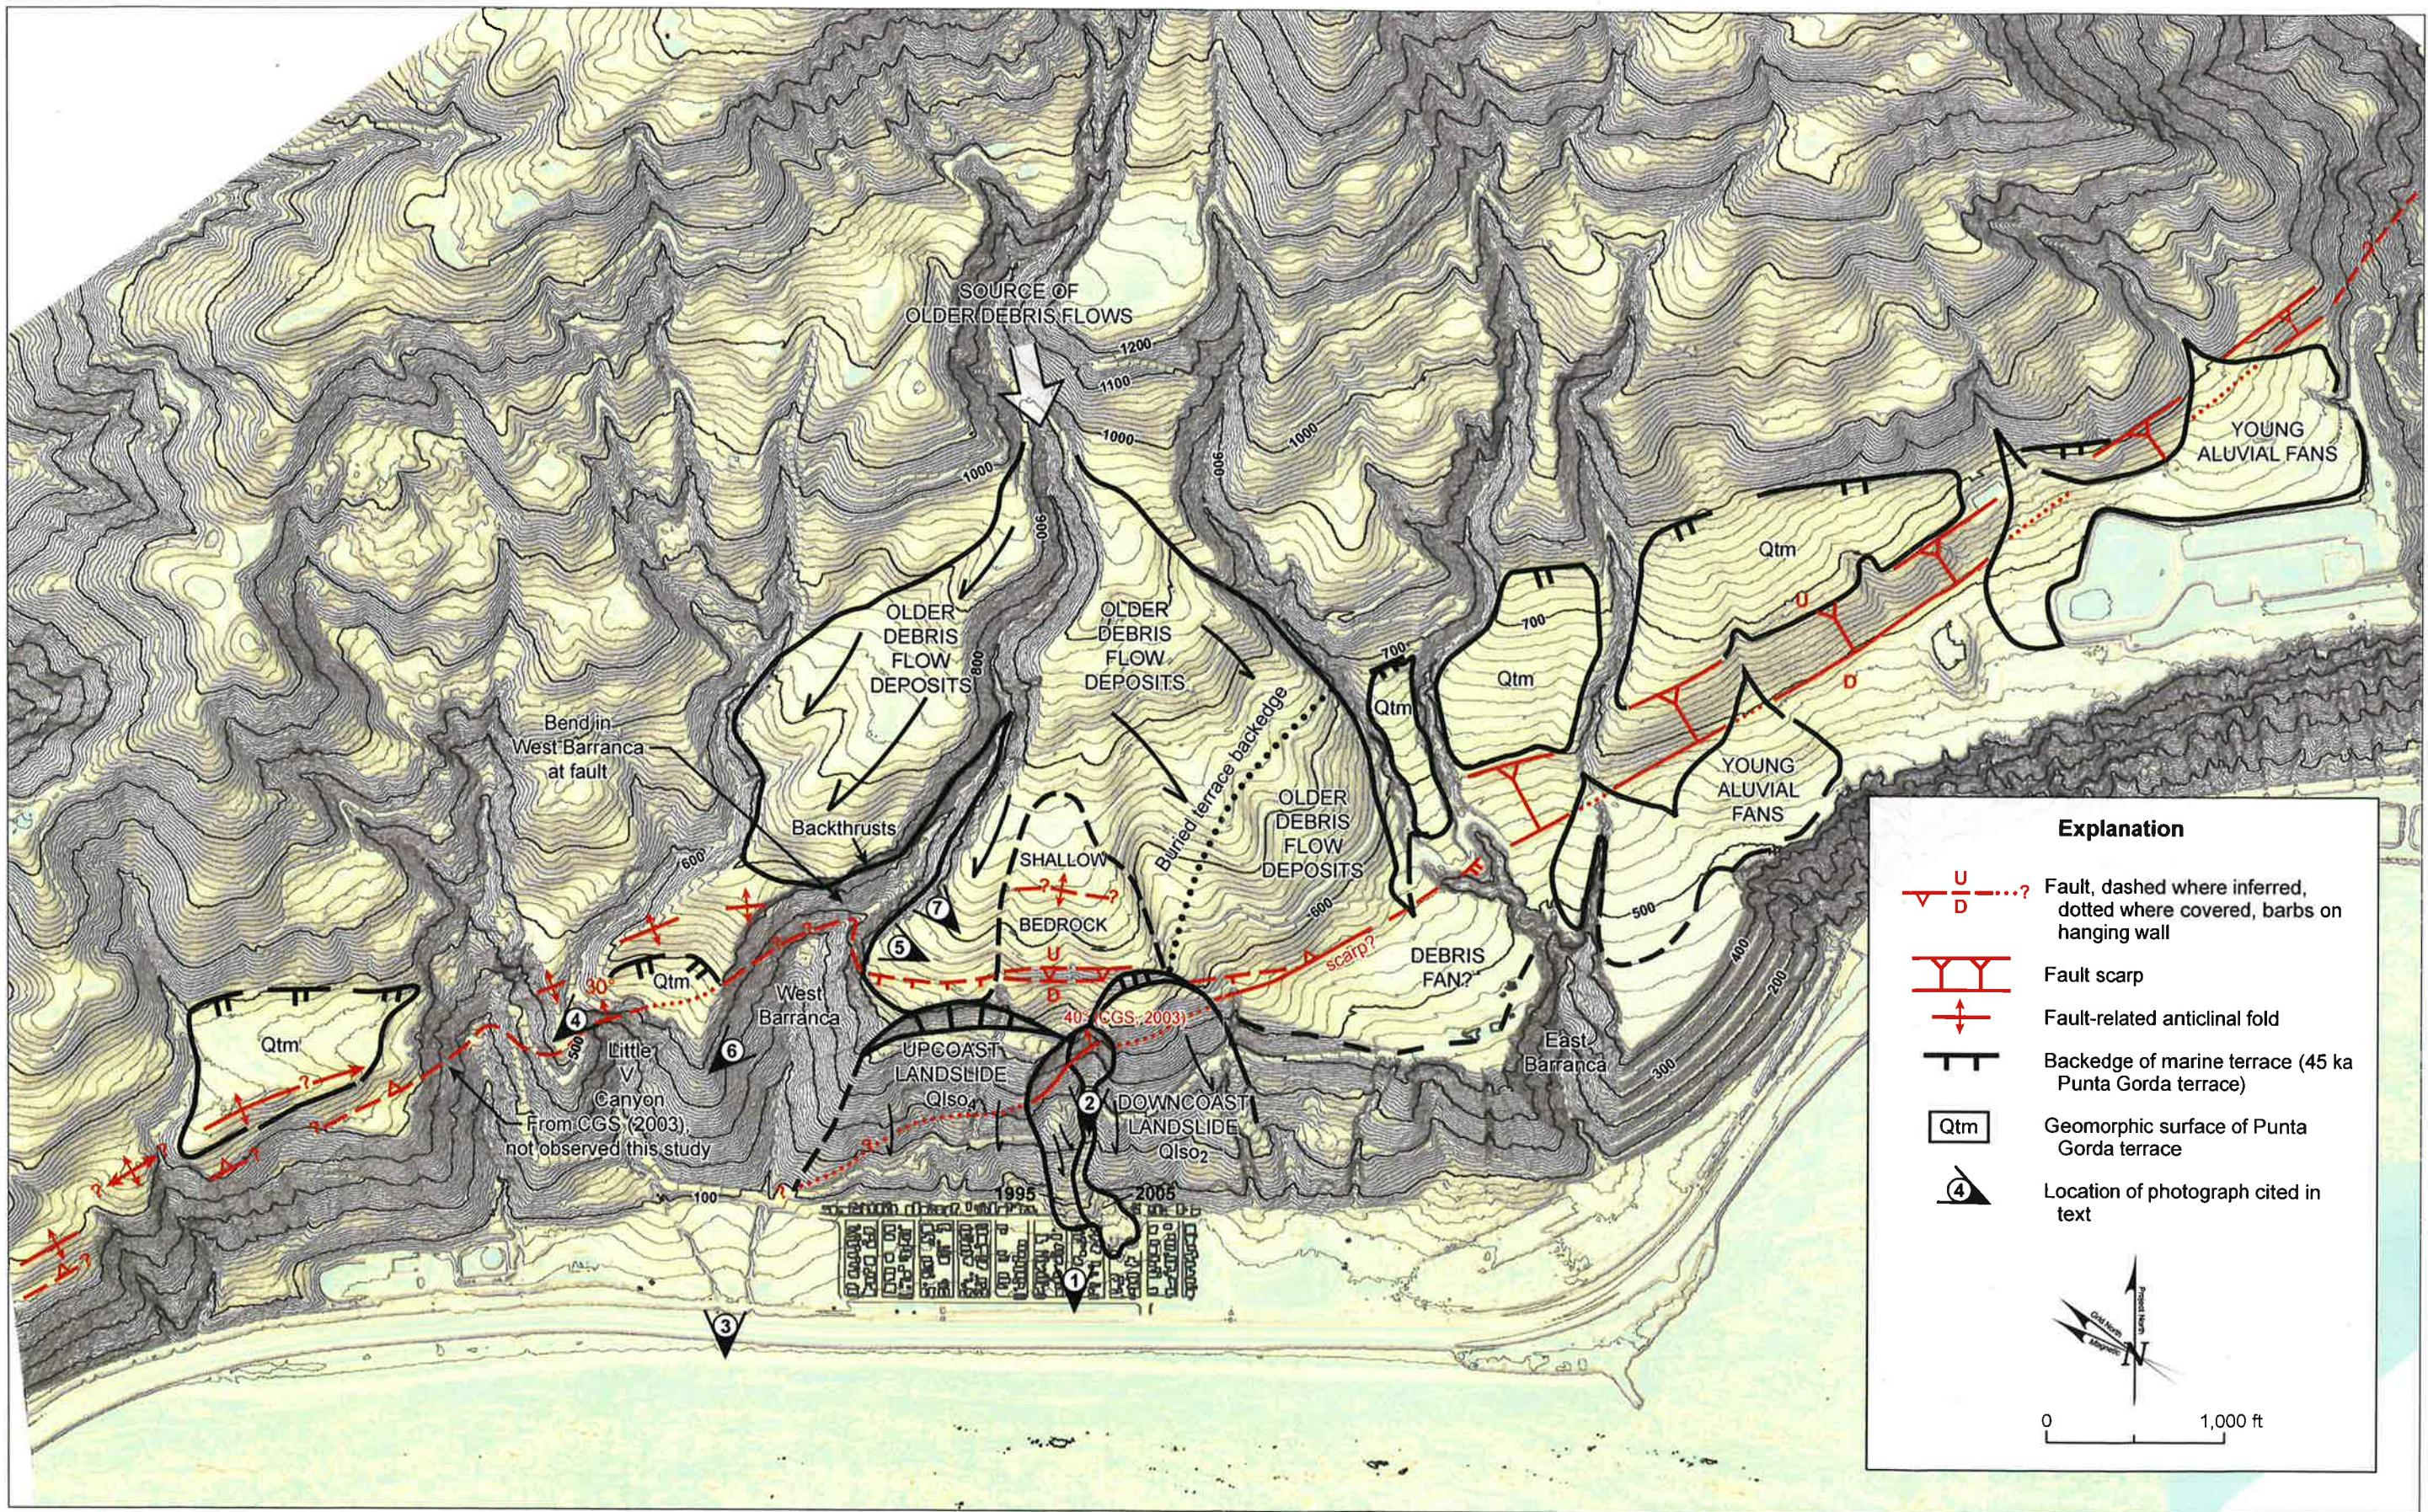
LA CONCHITA LANDSLIDE – PHASE 2
Figure 5.2

Map of Red Mountain Fault (this study) based on Geomorphic Features and Exposures (including observations from CGS, 2003)

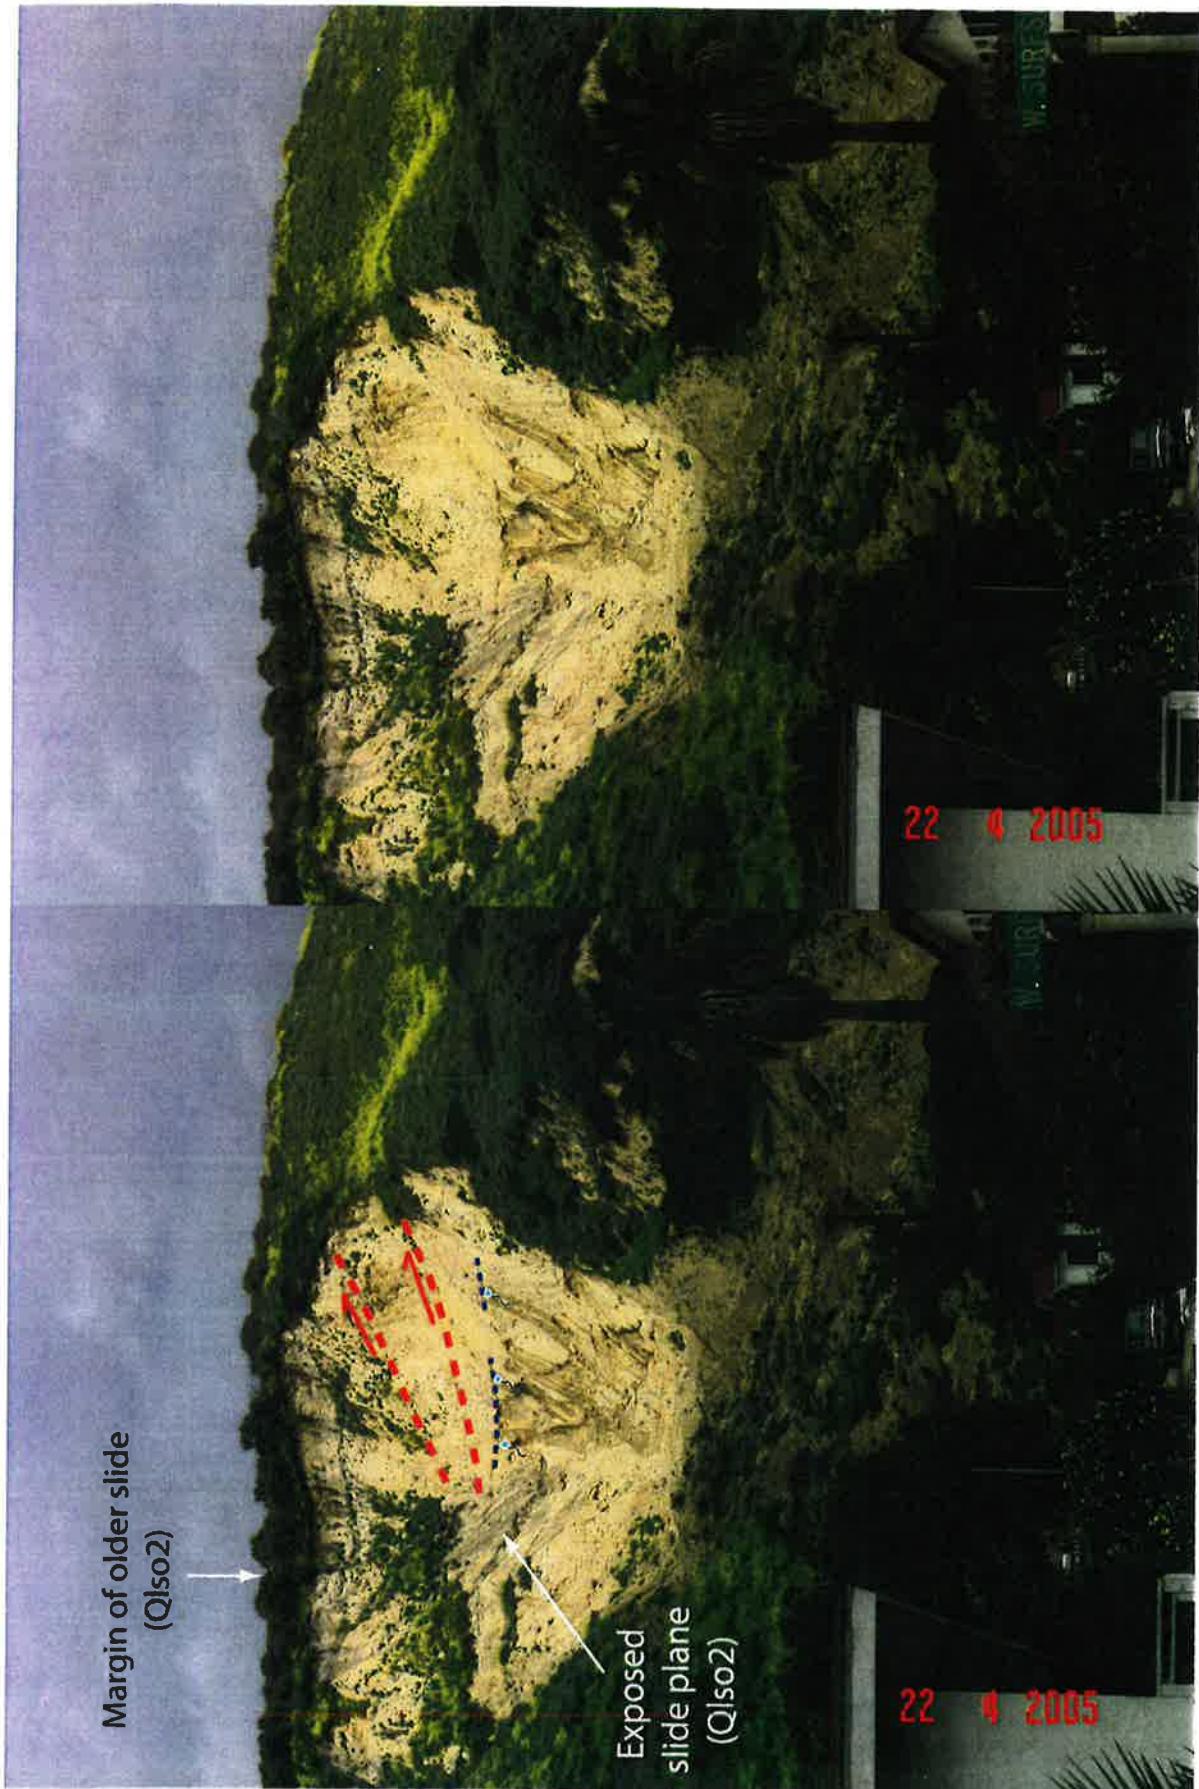
Photograph 1: Dated April 22, 2005 as provided by Jim O'Tousa (View to landward from La Conchita of 2005 slide, see Figure 5.2 for location)

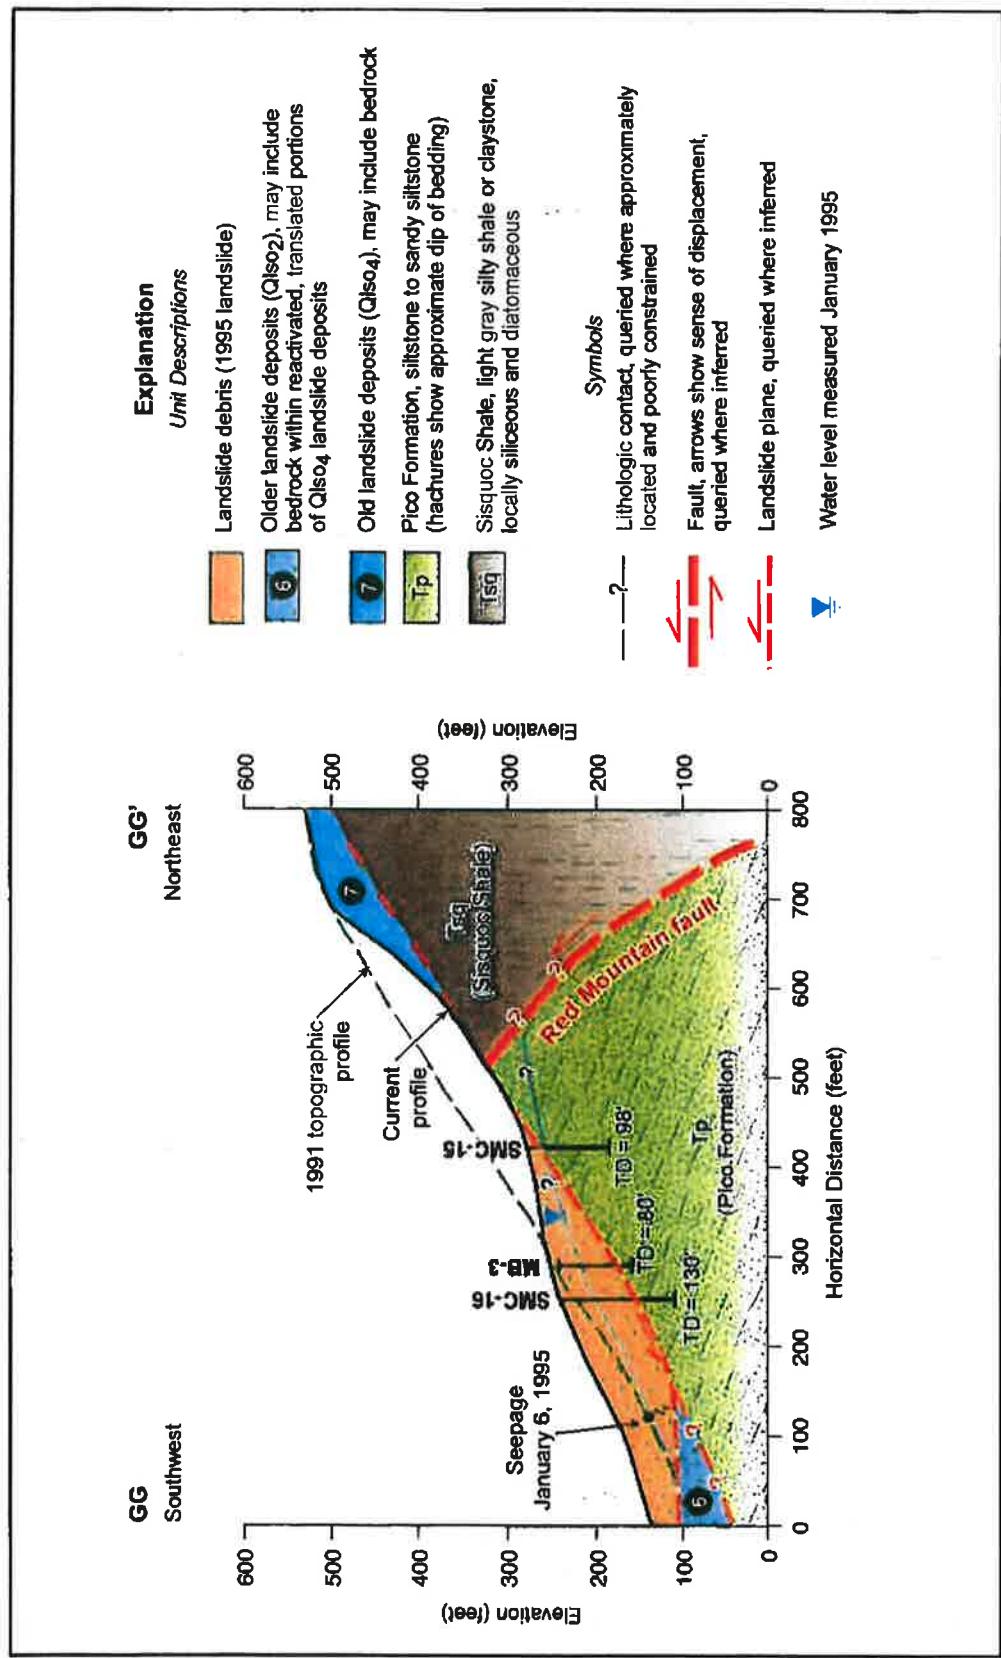
Geologic cross-section GG - GG' through 1995 landslide showing pre-failure water levels (see Figure B-1, Appendix B for location)

Figure 6.2 Geologic cross section through 1995 landslide showing pre-failure water levels.

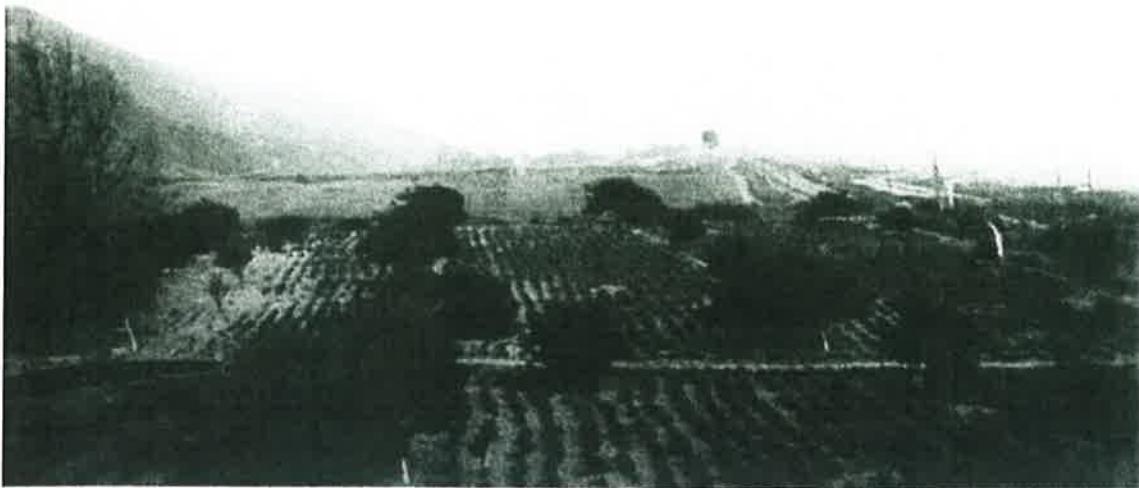
Figure 7.1 View to southeast from the former school house adjacent to the West Barranca of the coastal plain currently occupied by the community of La Conchita, vintage 1903-1911 (VCHS, 2005). Note the undulatory landscape composed of broad debris flow fans.

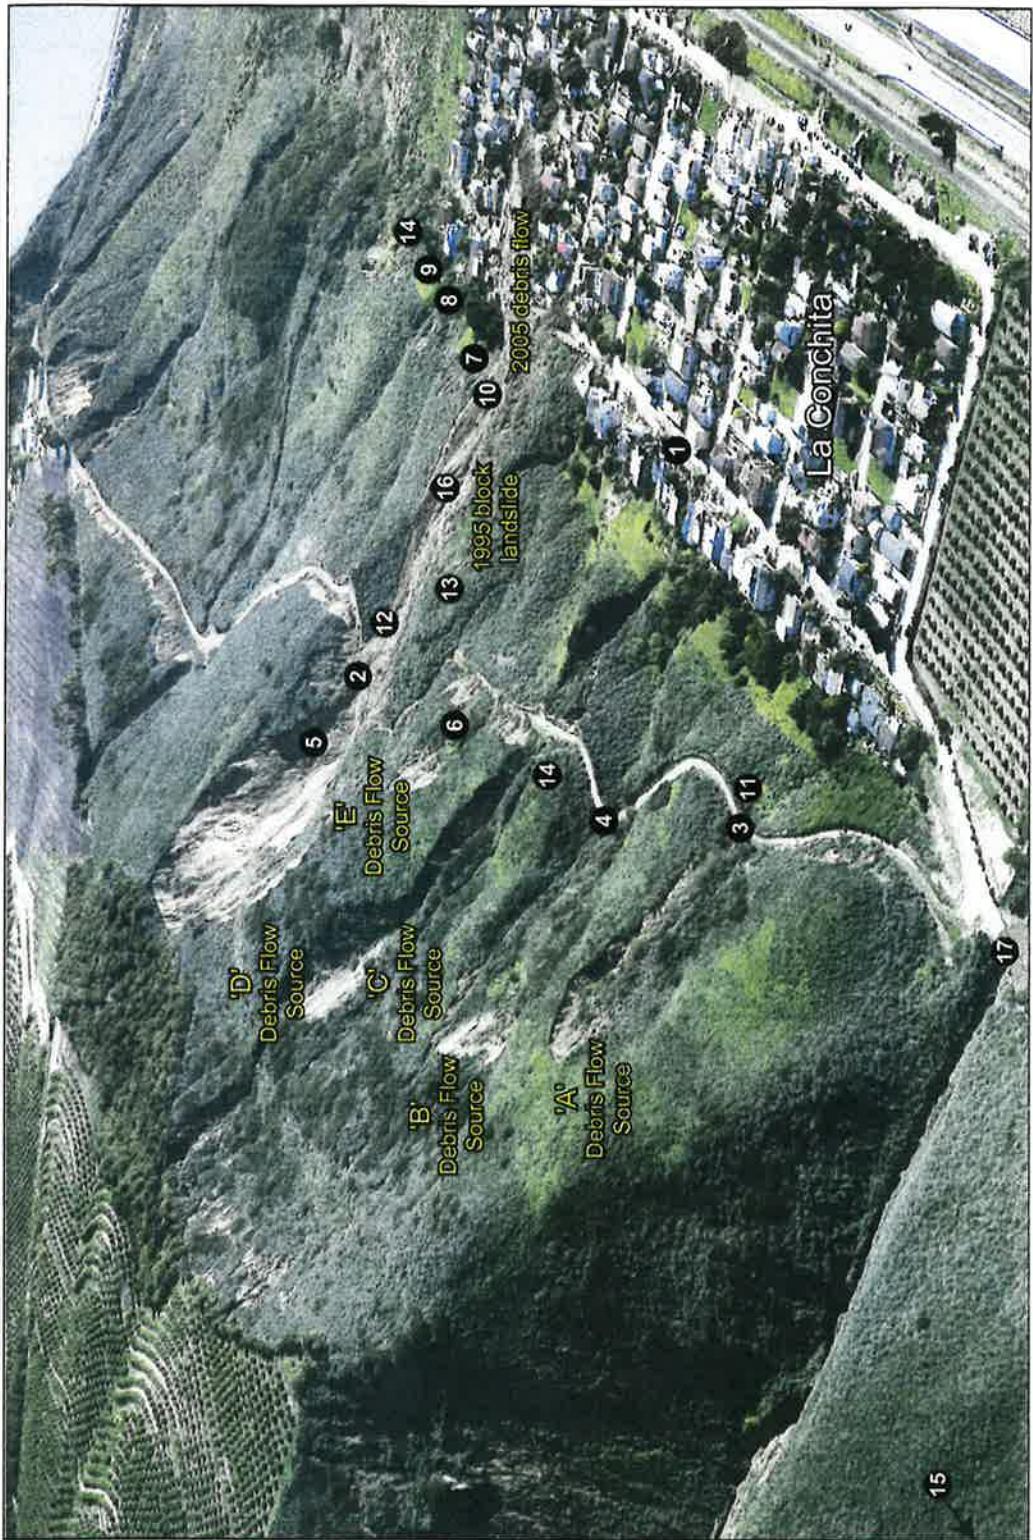
Figure 7.3 Photograph showing inventory of historical landslides and debris flows.

2005 photograph by Woodrow Higdon. See Table 7.1 for key to historic slope movement locations (shown as numbered locations).

Interpretation of aerial photographs dated March 31, 1969 (Table 7.2), indicates that debris flows from source area A (Figure 7.3) may have crossed Ranch Road and extended several tens of feet downhill. The volumes and extent of the flows are unknown.

Movement in debris source areas A and B (Figure 7.3), and associated debris that extended across Ranch Road, was documented by Blaise Cilweck (County of Ventura Senior Engineering Geologist) on March 30th, 1978 (unpublished files at Ventura County Public Works, 1978). The failure in area A consisted of a 120 by sixty feet wide slide that partially covered Ranch Road. The failure in area B consisted of a fifty-to seventy-foot-wide and 360-foot-long shallow slide that produced debris that extended across, and sixty feet downslope of, Ranch Road. Based on interpretation of color aerial photographs dated March 13, 1978, similar but less laterally extensive downslope displacement occurred in the other debris source areas (Table 7.2).

A letter from David Orr to the County of Ventura dated January 27, 1988 noted that debris flow areas fed by springs on the hillside above Ranch Road had produced increased debris on the road in the previous several years. The Ranch stockpiled the slide debris along the roadside and then hauled the debris out to West Barranca (La Conchita Ranch, Letter to Joe Hanna, Ventura County Public Works, 1988). Based on examination of available aerial photographs (Table 7.2), movement within debris area E occurred between December 10, 1986 and June of 1987. The slope movement within source area E (Figure 7.3) occurred in a previously stable area with no established downslope gully.

We applied a multidisciplinary approach to develop a model of debris flow hazard at a local scale in La Conchita. First, we produced an inventory of past debris flows, based on historical accounts and comparison of observed changes on vintage aerial photographs, as discussed above (Figure 7.3). We then interpreted LiDAR-based topography and stereo-paired aerial photographs to delineate upslope debris flow source areas, map debris flow transport paths (gullies), and estimate the lateral extent and thicknesses of historical and pre-historic debris flow fans on the coastal plain. Debris flow source areas used in our model are shown on Figure 8.7.

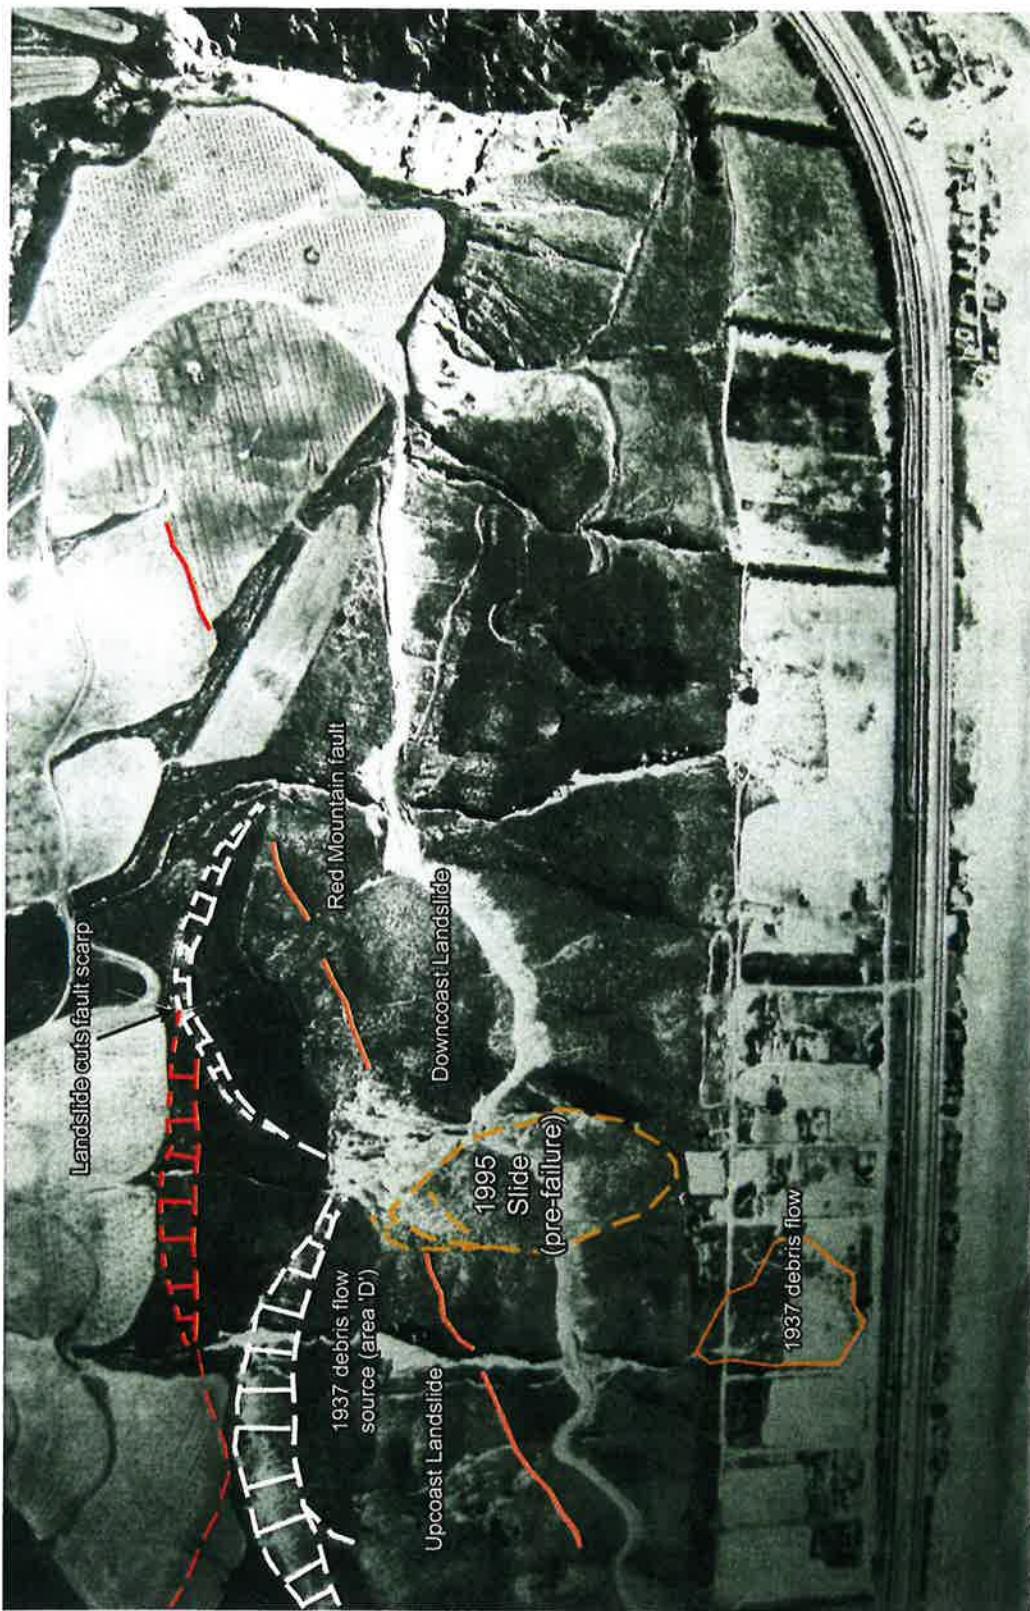
LA CONCHITA LANDSLIDE - PHASE 2
Figure 7.5

WLA Annotated 1939 aerial photograph showing intersection of two older slides

Figure 7.5 Annotated 1937 aerial photograph showing intersection of two older slides.

were covered by the debris flow. This debris flow can be seen on historical aerial photographs (Figure 7.5).

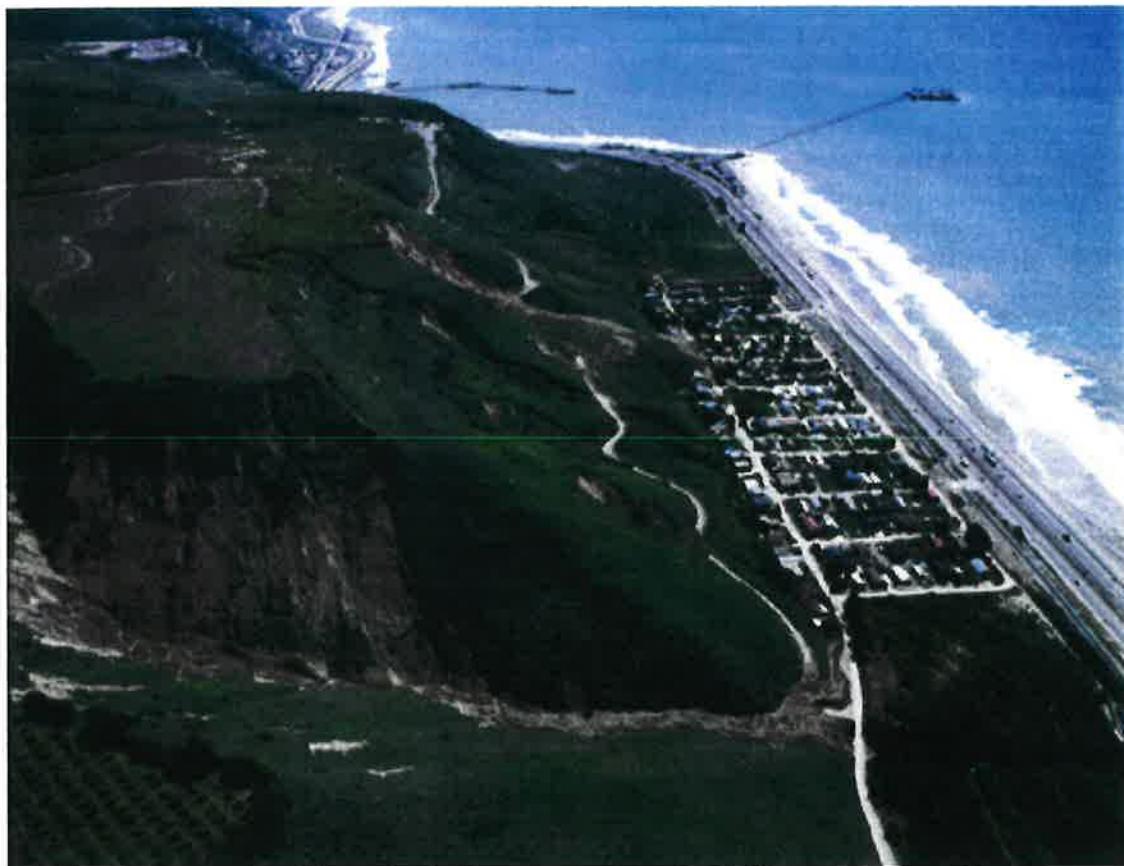
Figure 7.7 Aerial oblique view of the destructive debris flow that emanated from West Barranca on the evening of March 10, 1995, damaging at least three homes. Photograph provided by Woodrow Higdon (copyrighted by Geo-Tech Imagery).

Following the March 4, 1995 landslide, in the evenings of March 9th and 10th, an intense series of storms triggered debris flows from the West Barranca, damaging three to five homes in the northwestern corner of La Conchita (Figure 7.7). Ventura County Geologist Jim O'Tousa noted mudflow debris had been cleared off of Carpinteria Avenue and pushed to the side, forming a crude berm up to three feet high (Ventura County, memorandum from Jim O'Tousa to Jim Fisher, dated March 21, 1995). At the intersection of Vista del Rincon and Ranch Road, O'Tousa noted that culverts beneath Ocean View Road had been clogged and evidence of two discrete mudflow events could be seen, an early flow that blocked the drainage and a subsequent flow that was diverted to the east, down the road and into the community.

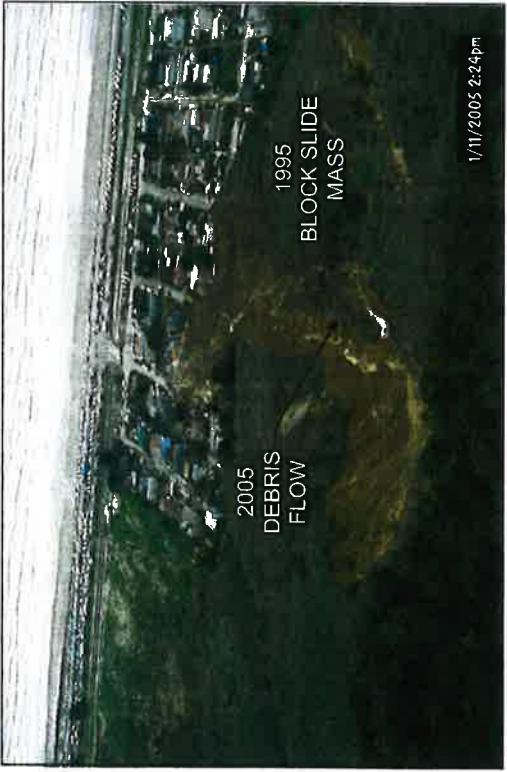
Post-1995 Slide

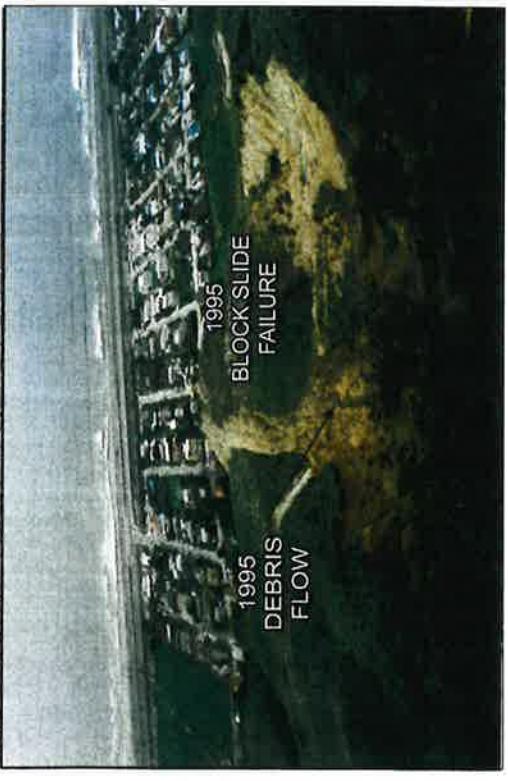
Post-2005 Slide

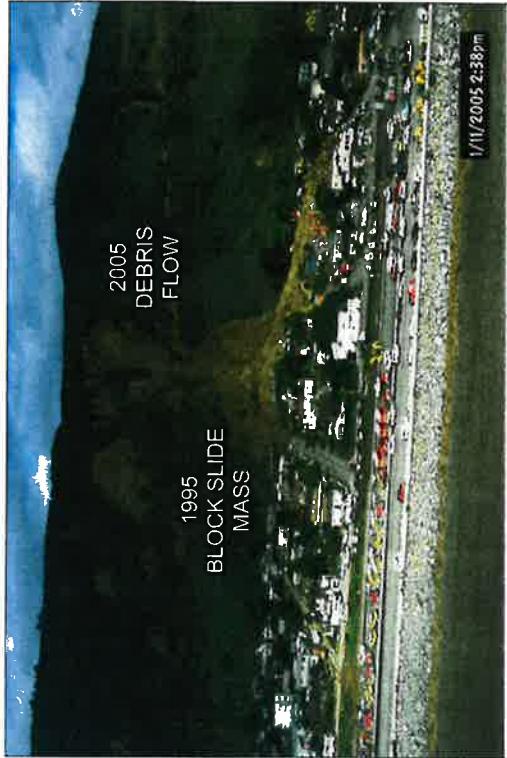
Photographs of 1995 slope failures compared to 2005 slope failures (photographs provided by Pam Irvine for 1995 and Jim O'Tousa for 2005)

Figure 7.8 Photographs of 1995 slope failures compared to 2005 slope failures.

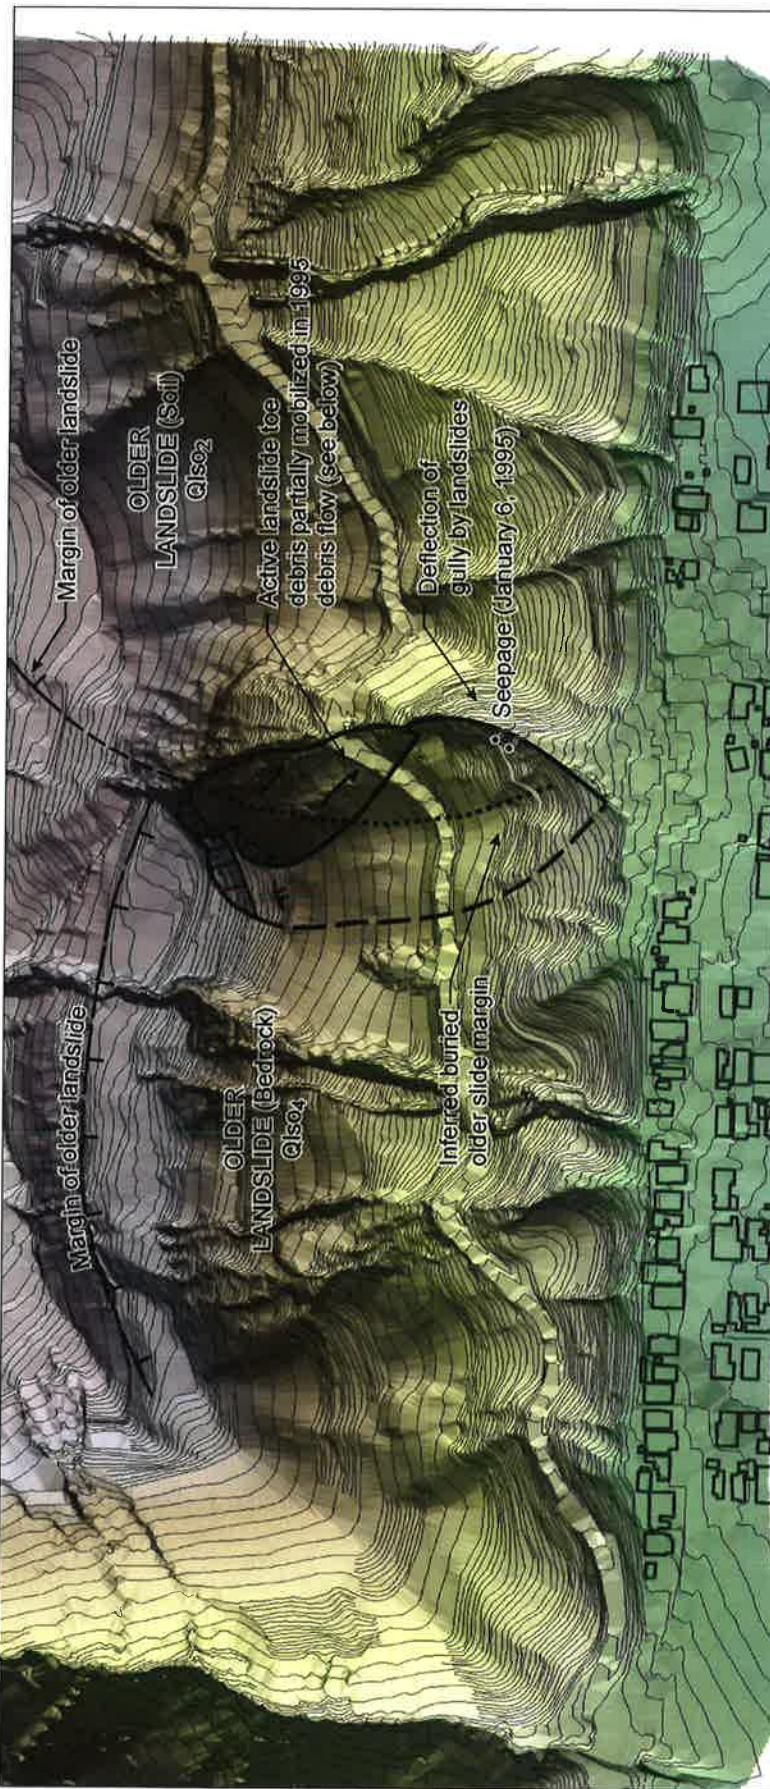
Pre-1995 Slide

1991 Topography (Source: Western Aerial Surveyors)

Figure 7.9 Evolution of 1995 and 2005 slope failures shown on Digital Elevation Models derived from civil surveys (1991, 1995, and 2006).

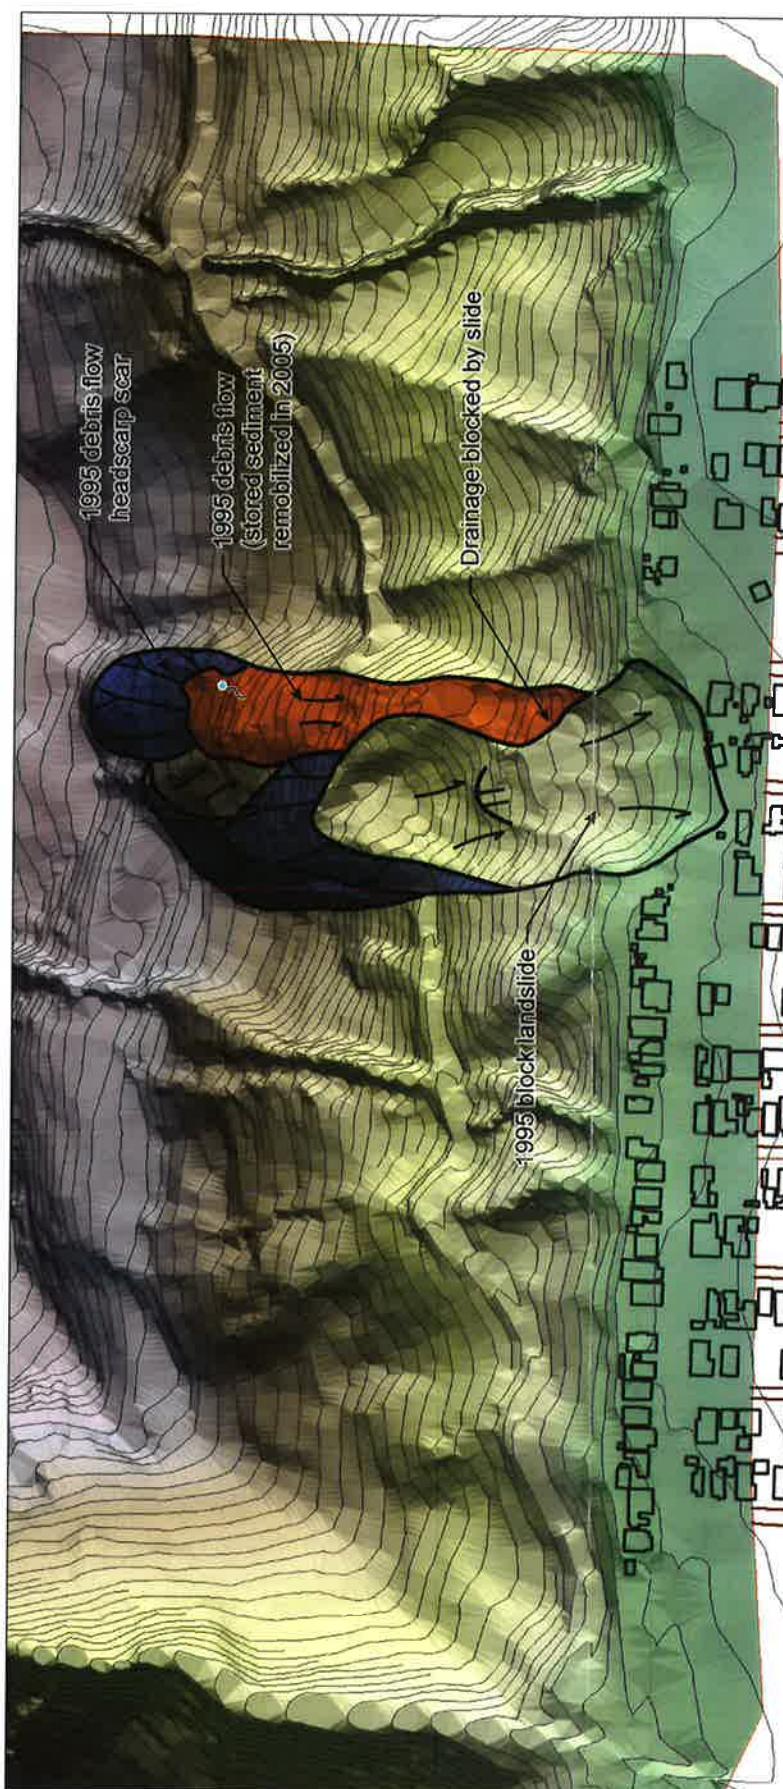
Post-1995 Slide

1995 Topography (Source: Robert J. Lung and Associates, Stoney Miller 1995)

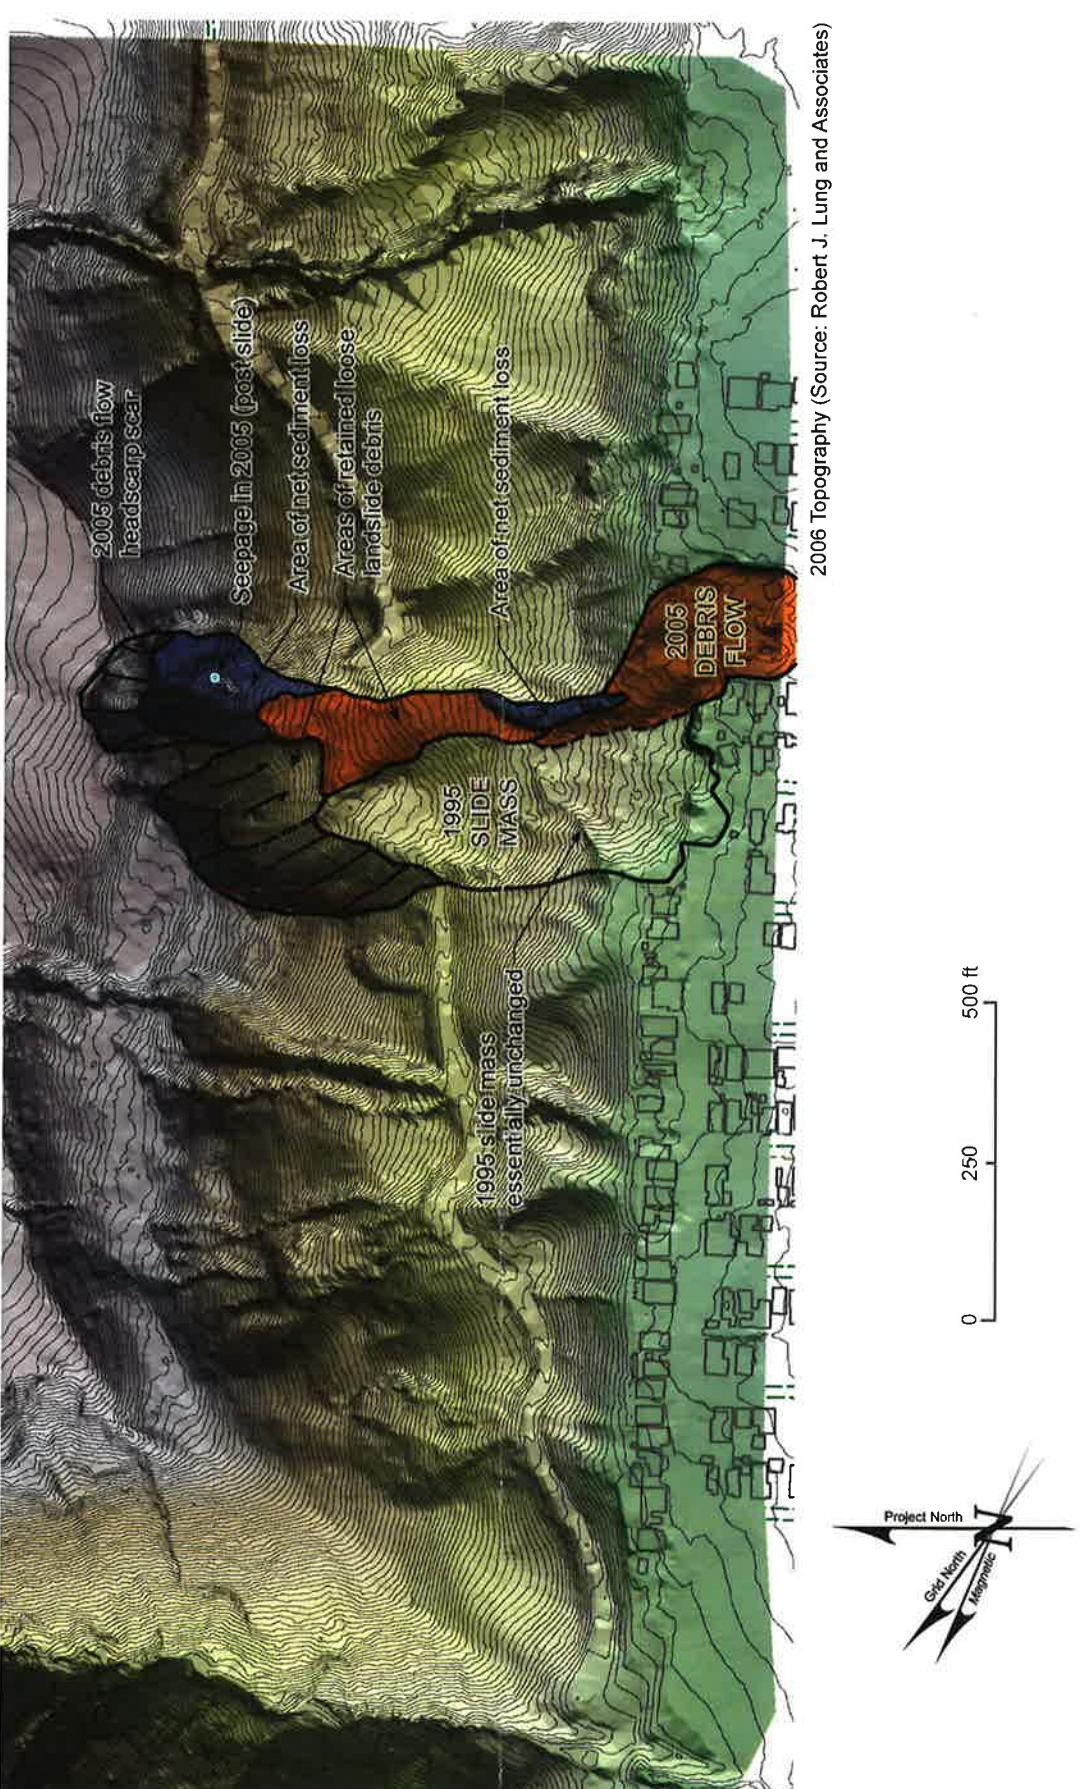
Post-2005 Slide

2006 Topography (Source: Robert J. Lung and Associates)

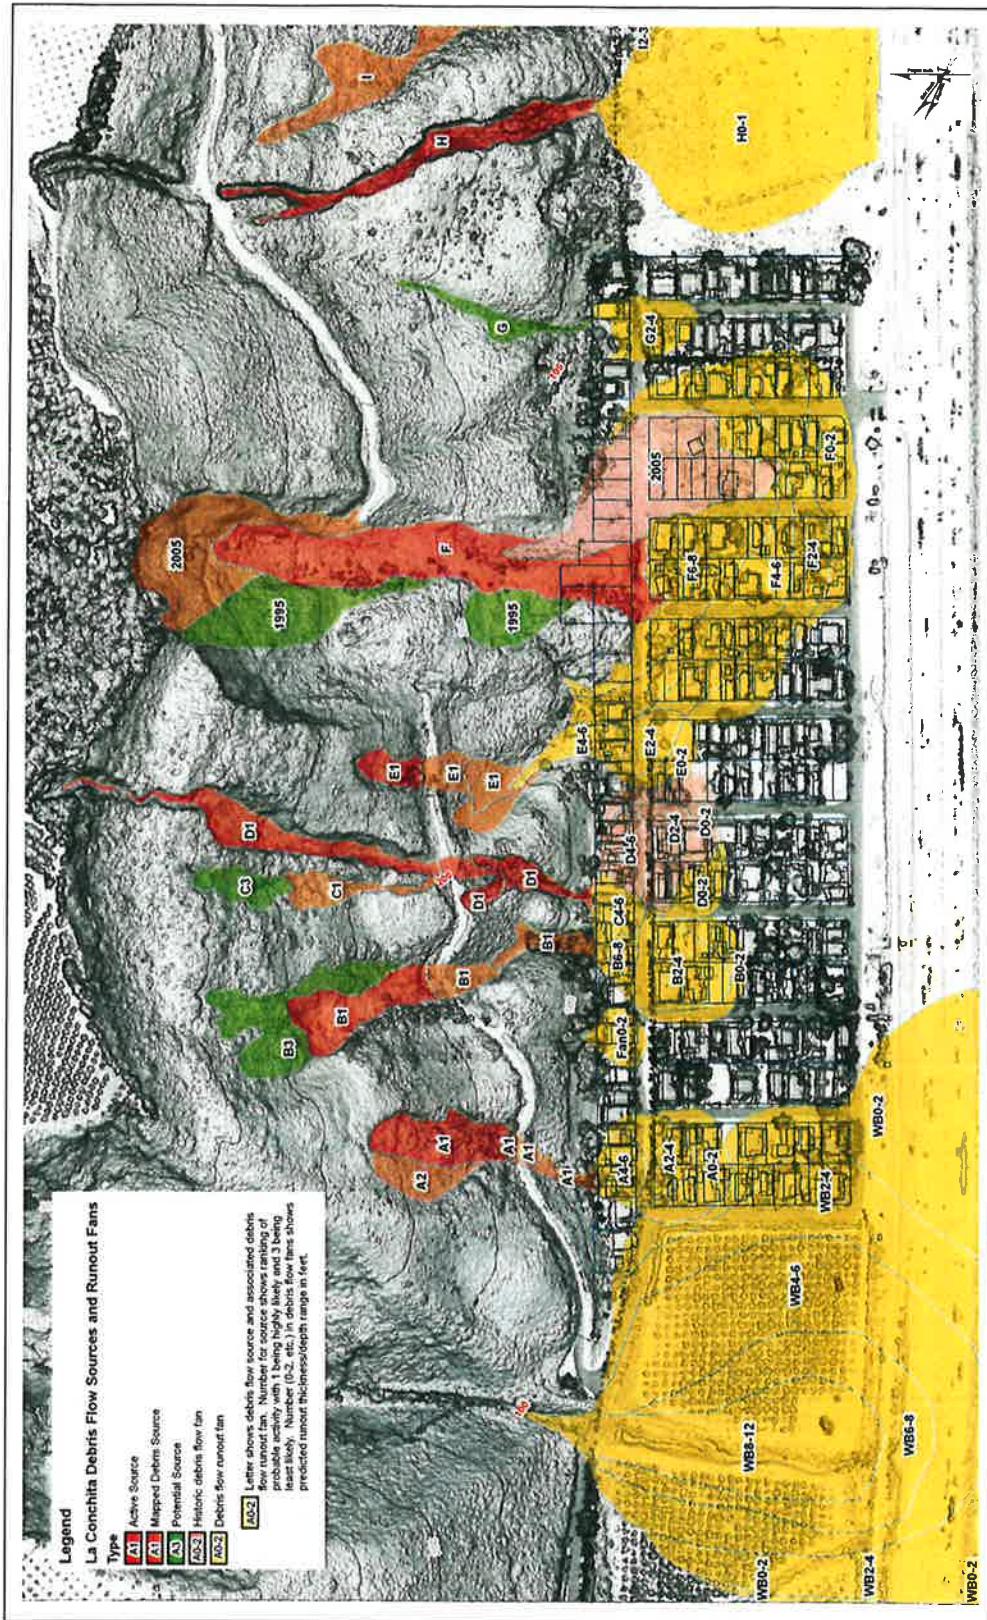
Map of Debris Flow Sources and Run-out Fans Showing Inferred Depth Ranges

For example, a topographic map of a historic debris flow dated December 1937, shows the western edge of the 'recent build up' along Oxnard Avenue, and the eastern edge along the range front with the 'line of principal flow' trending south along the range front before turning southwest, between Bakersfield Avenue and the ally to the east (Figure 7.2; Ventura County Map #31600, provided by David Orr, La

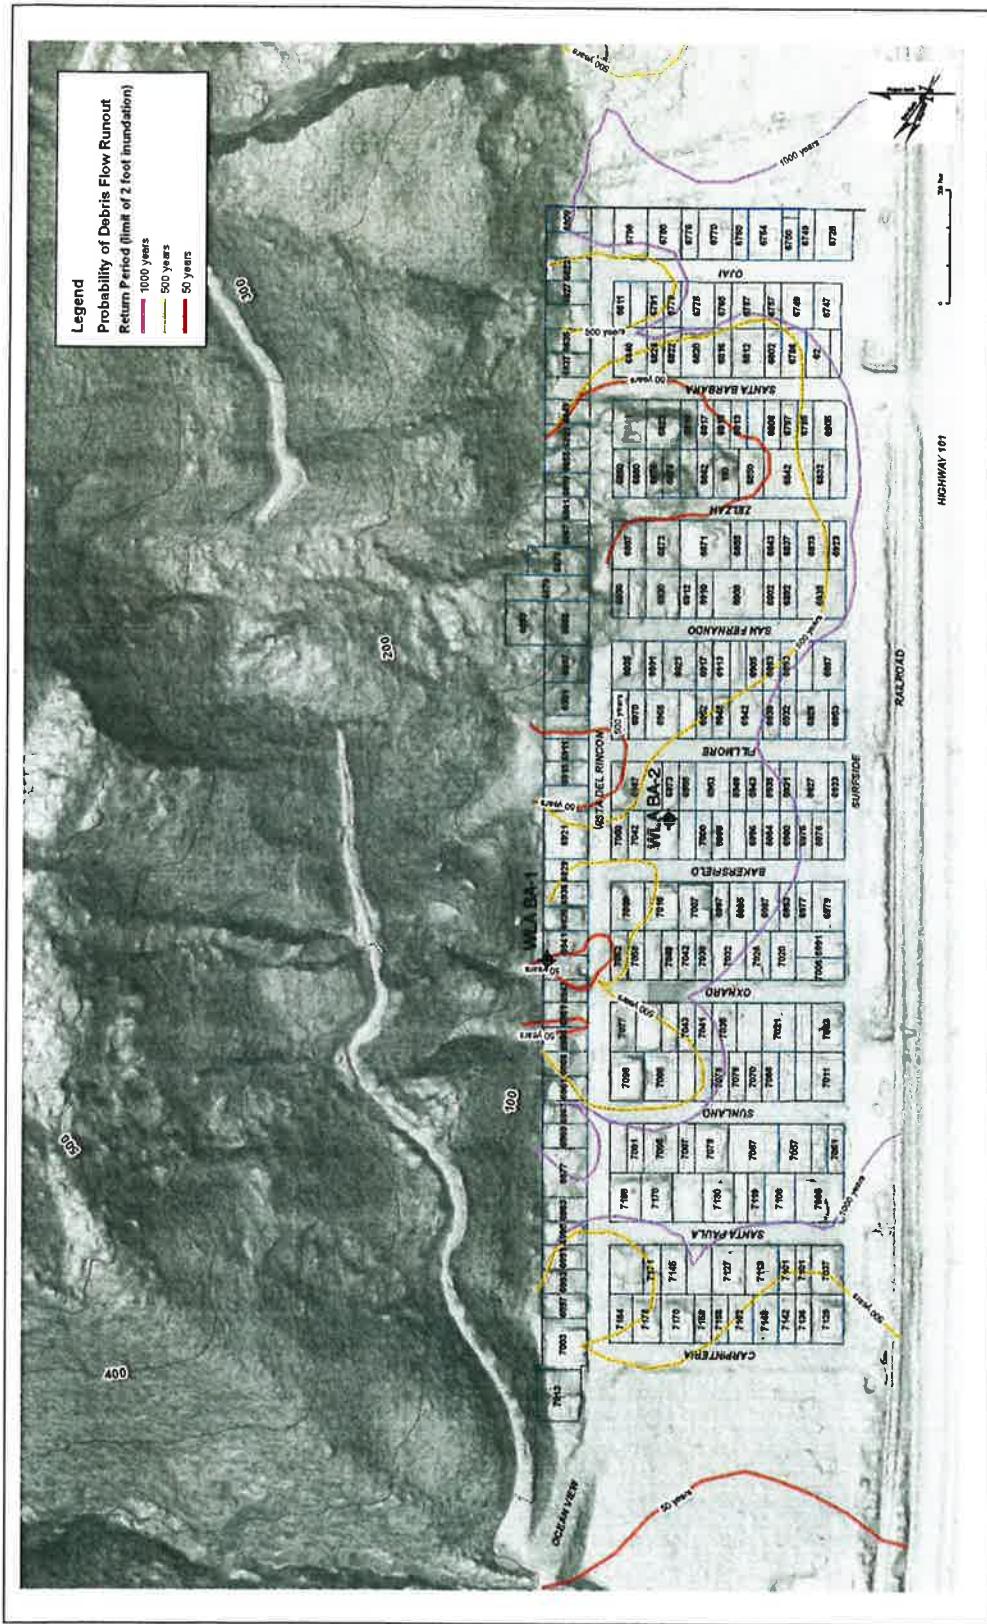
Map showing Probability of Debris Flow Run-out (limits of two-foot inundation)

This information was integrated with our existing maps of debris fans, interpretation of available borings, and historical records to produce a map of the probable extent of two-feet run-out depths for return periods of 50, 475, and 1,000 years (Figure 8.8). This map is intended for conceptual design purposes
