La Conchita Slope Stabilization Project

Geological Study
La Conchita, Ventura County

Contract No. 3108855 (CRN 17600307169846)
Project No. 122259A

August 28, 2009

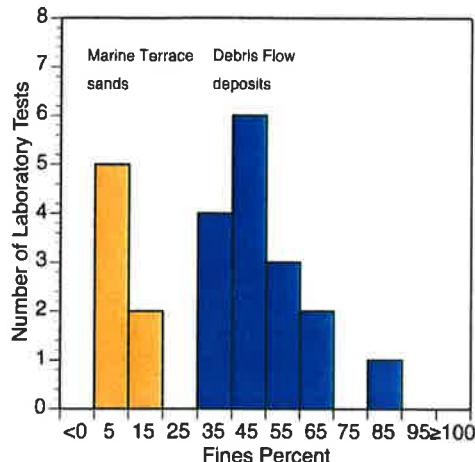
Figure 9.2 Histogram of percentage of fines in buried marine terrace sands versus debris flow deposits derived from laboratory grain-size analyses in geotechnical reports.

Geotechnical boring logs and Cone Penetrometer (CPT) soundings provide lithologic data that are useful for assessing liquefaction susceptibility. For example, geotechnical borings commonly include information on soil texture (USCS) from field observations and laboratory particle size distribution analyses. Compiled borings and recent geotechnical reports (Pacific Materials Laboratories, 2006) suggest that deposits under La Conchita are predominately fine-grained (Figure 9.2). Site conditions consist generally of clayey artificial fill, dense beach sands and hard clayey Pico Formation at depth.

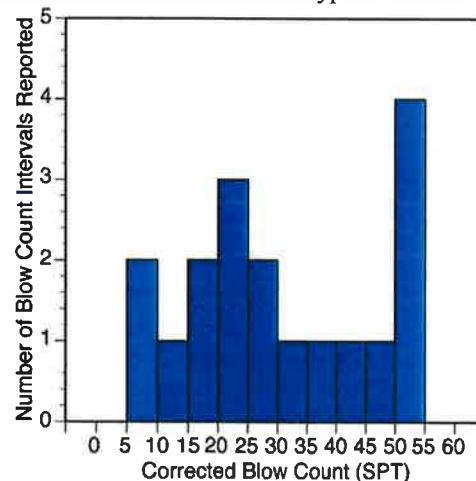
Figure 9.3 Histogram of percentage of fines in buried marine terrace sands versus debris flow deposits derived from borehole logs in geotechnical reports.

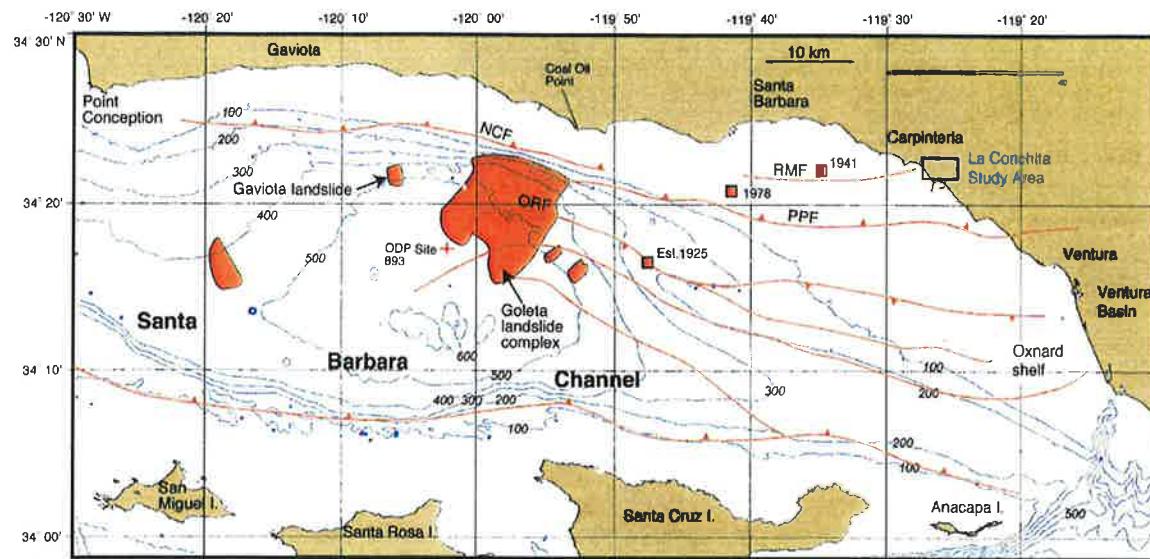
Figure 9.4 Map of the western Santa Barbara Channel showing known submarine landslides, major faults (red lines), and historical earthquakes (red squares). Faults include the Pitas Point (PPF), the Red Mountain (RMF), the North Channel (NCF), and the Oak Ridge (ORF) faults (from Fisher and others, 2005).

triggering large submarine slope failures. Vertical movement on reverse faults can cause significant displacement of the seafloor producing tsunami. In addition, offshore strike-slip faults have sinuous traces with structural bends or step-overs that can cause local uplift or subsidence during an earthquake, triggering tsunami (Legg and Kennedy, 1991). Numerous major on-shore fault systems extend offshore in the vicinity of La Conchita, including the Red Mountain and Oak Ridge faults (Figure 9.4). Offshore sources of particular interest for tsunami generation include the Channel Islands Thrust, a north-dipping blind thrust fault responsible for uplift of the Channel Islands and possibly capable of generating six feet (two meters) run-up heights with up to sixty feet (eighteen meters), if a large enough earthquake is associated with triggered submarine landslides (Borrero and others, 2004).

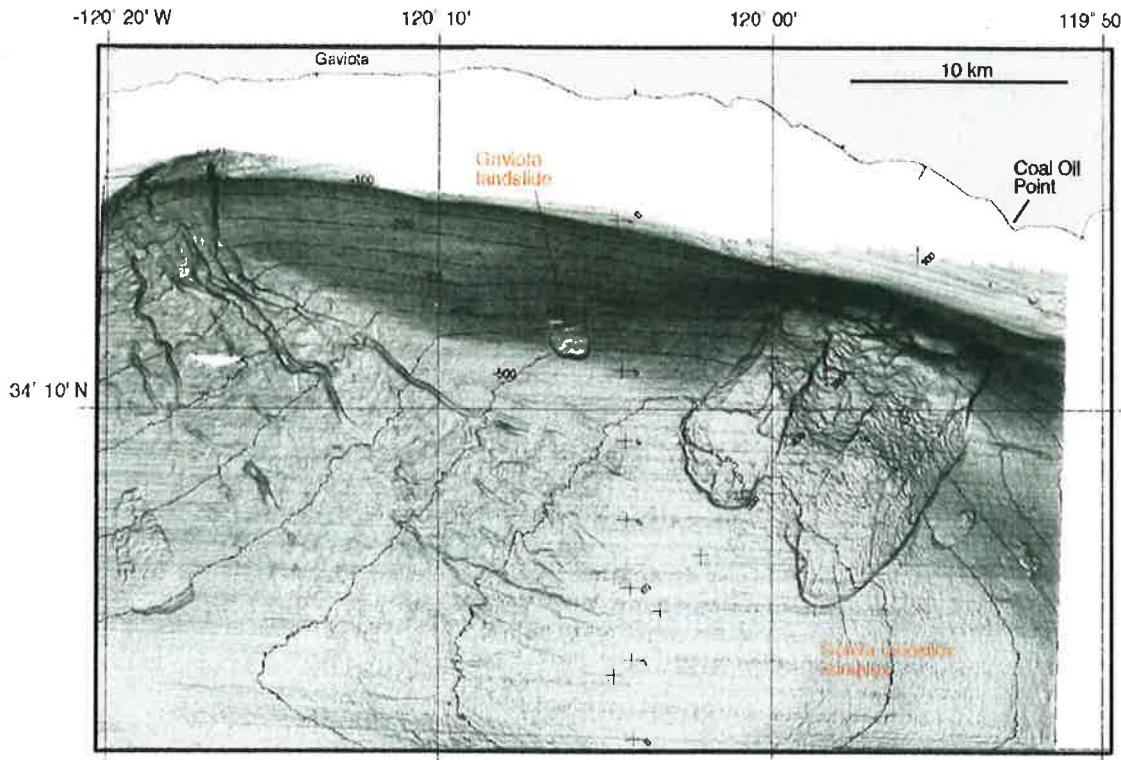
Figure 9.5 Known offshore landslide sources, including the Goleta landslide complex and Gaviota landslide (as mapped by Fisher and others, 2005).

miles (eleven kilometers) wide, series of landslides could be associated with failures on the order of five billion cubic yards of material. A nearby smaller submarine landslide, the Gaviota landslide, has a total volume of roughly a quarter of a billion cubic yards and is thought to be capable of generating a local tsunami run-up heights of about six feet (two meters), based on research by Fisher and others (2005). However, even a tsunami this large from a submarine landslide located immediately offshore likely is insufficient to significantly inundate the community of La Conchita.

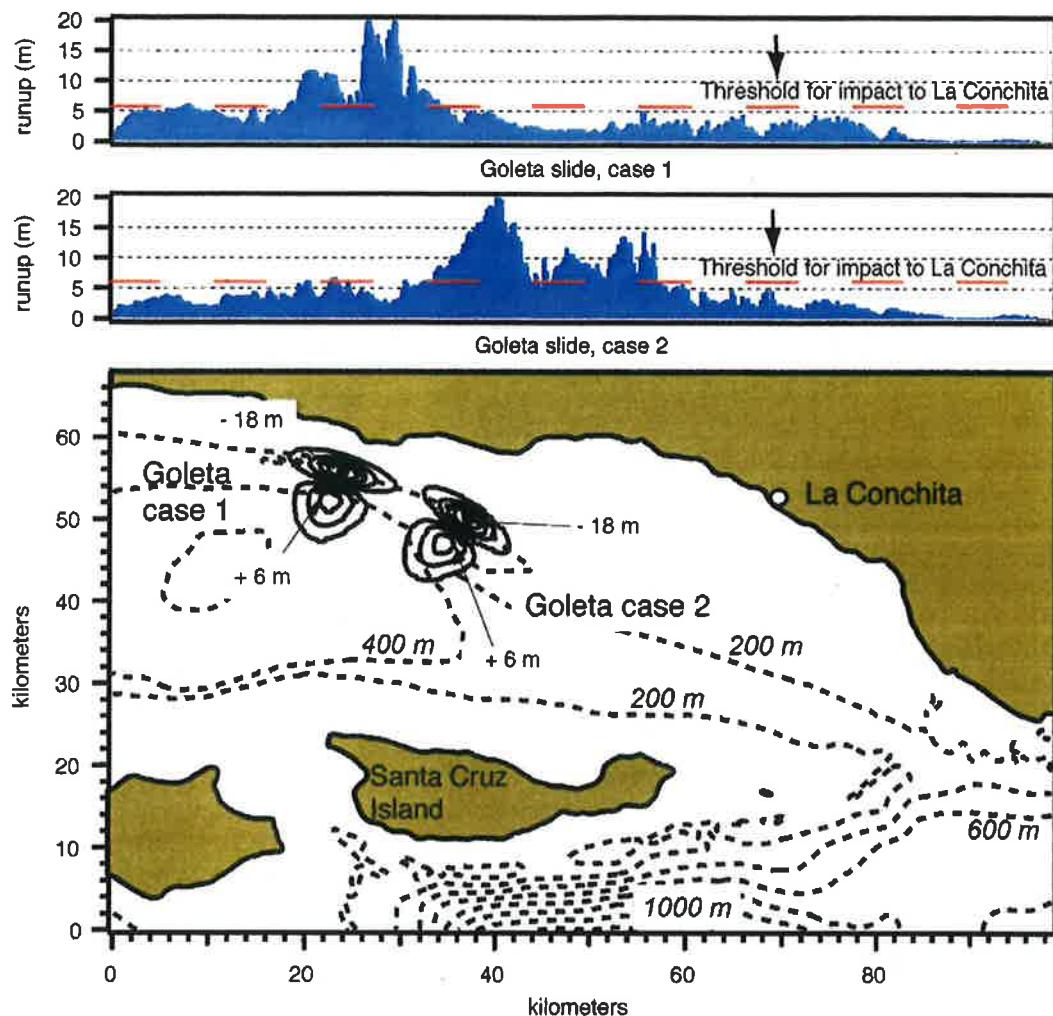
Figure 9.6 Estimated tsunami run-up from the Goleta offshore landslide sources (Fisher and others, 2005).

A larger submarine landslide such as failures associated with the Goleta landslide complex could generate tsunami run-ups of up to sixty feet (twenty meters), sufficient to damage La Conchita. (Fisher and others, 2005). However, inundation from waves triggered by submarine landslides is expected to be highly focused with only narrow (five to six miles, or roughly ten kilometers, wide) sections of the immediate shoreline impacted. As shown on Figure 9.6, the estimated distribution of tsunami run-up heights from the offshore Goleta slides does not exceed the minimum elevation threshold for inundation of La Conchita. In addition, similar large landslide been not been identified immediately offshore of La Conchita. However, other possible landslide sources may exist in deeper water or off the Channel Islands. Further study is required to better characterize potential additional sources but current research suggests that known offshore landslide sources for tsunami run-up are unlikely, or at least have a low probability, of causing sufficient run-up to inundate the community of La Conchita.

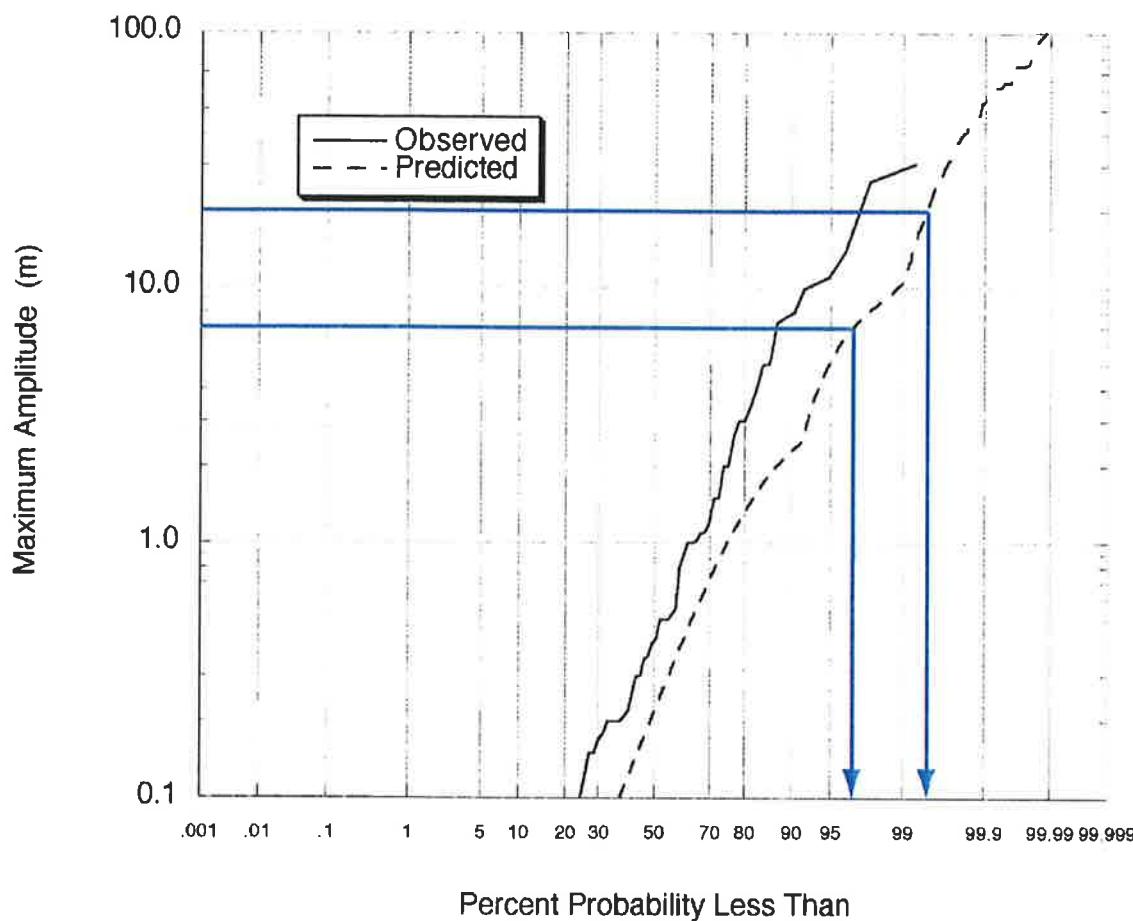
Figure 9.7 Comparison of the predicted tsunami amplitude probability distribution of Southern California versus the measured peak run-up of Pacific Basin tsunami during the 1990s (from Watts, 2004). Blue arrows show the approximate range of tsunami amplitude required to inundate La Conchita. Further study is required to determine whether additional near-shore bathymetry may influence local tsunami run-up in the La Conchita Study Area.

In summary, based on the historical record, past tsunami have not been large enough to inundate the community of La Conchita. Recent research has identified nearby offshore landslide and fault sources with the potential to generate large tsunami. However, insufficient information currently exists to fully evaluate the probability of future tsunami inundation and run-up heights in the vicinity of La Conchita. Our review of the available research strongly suggests that tsunami run-up is not a significant hazard within the 100- and 500-year periods of interest, compared to more frequent and potentially damaging landslide hazards.

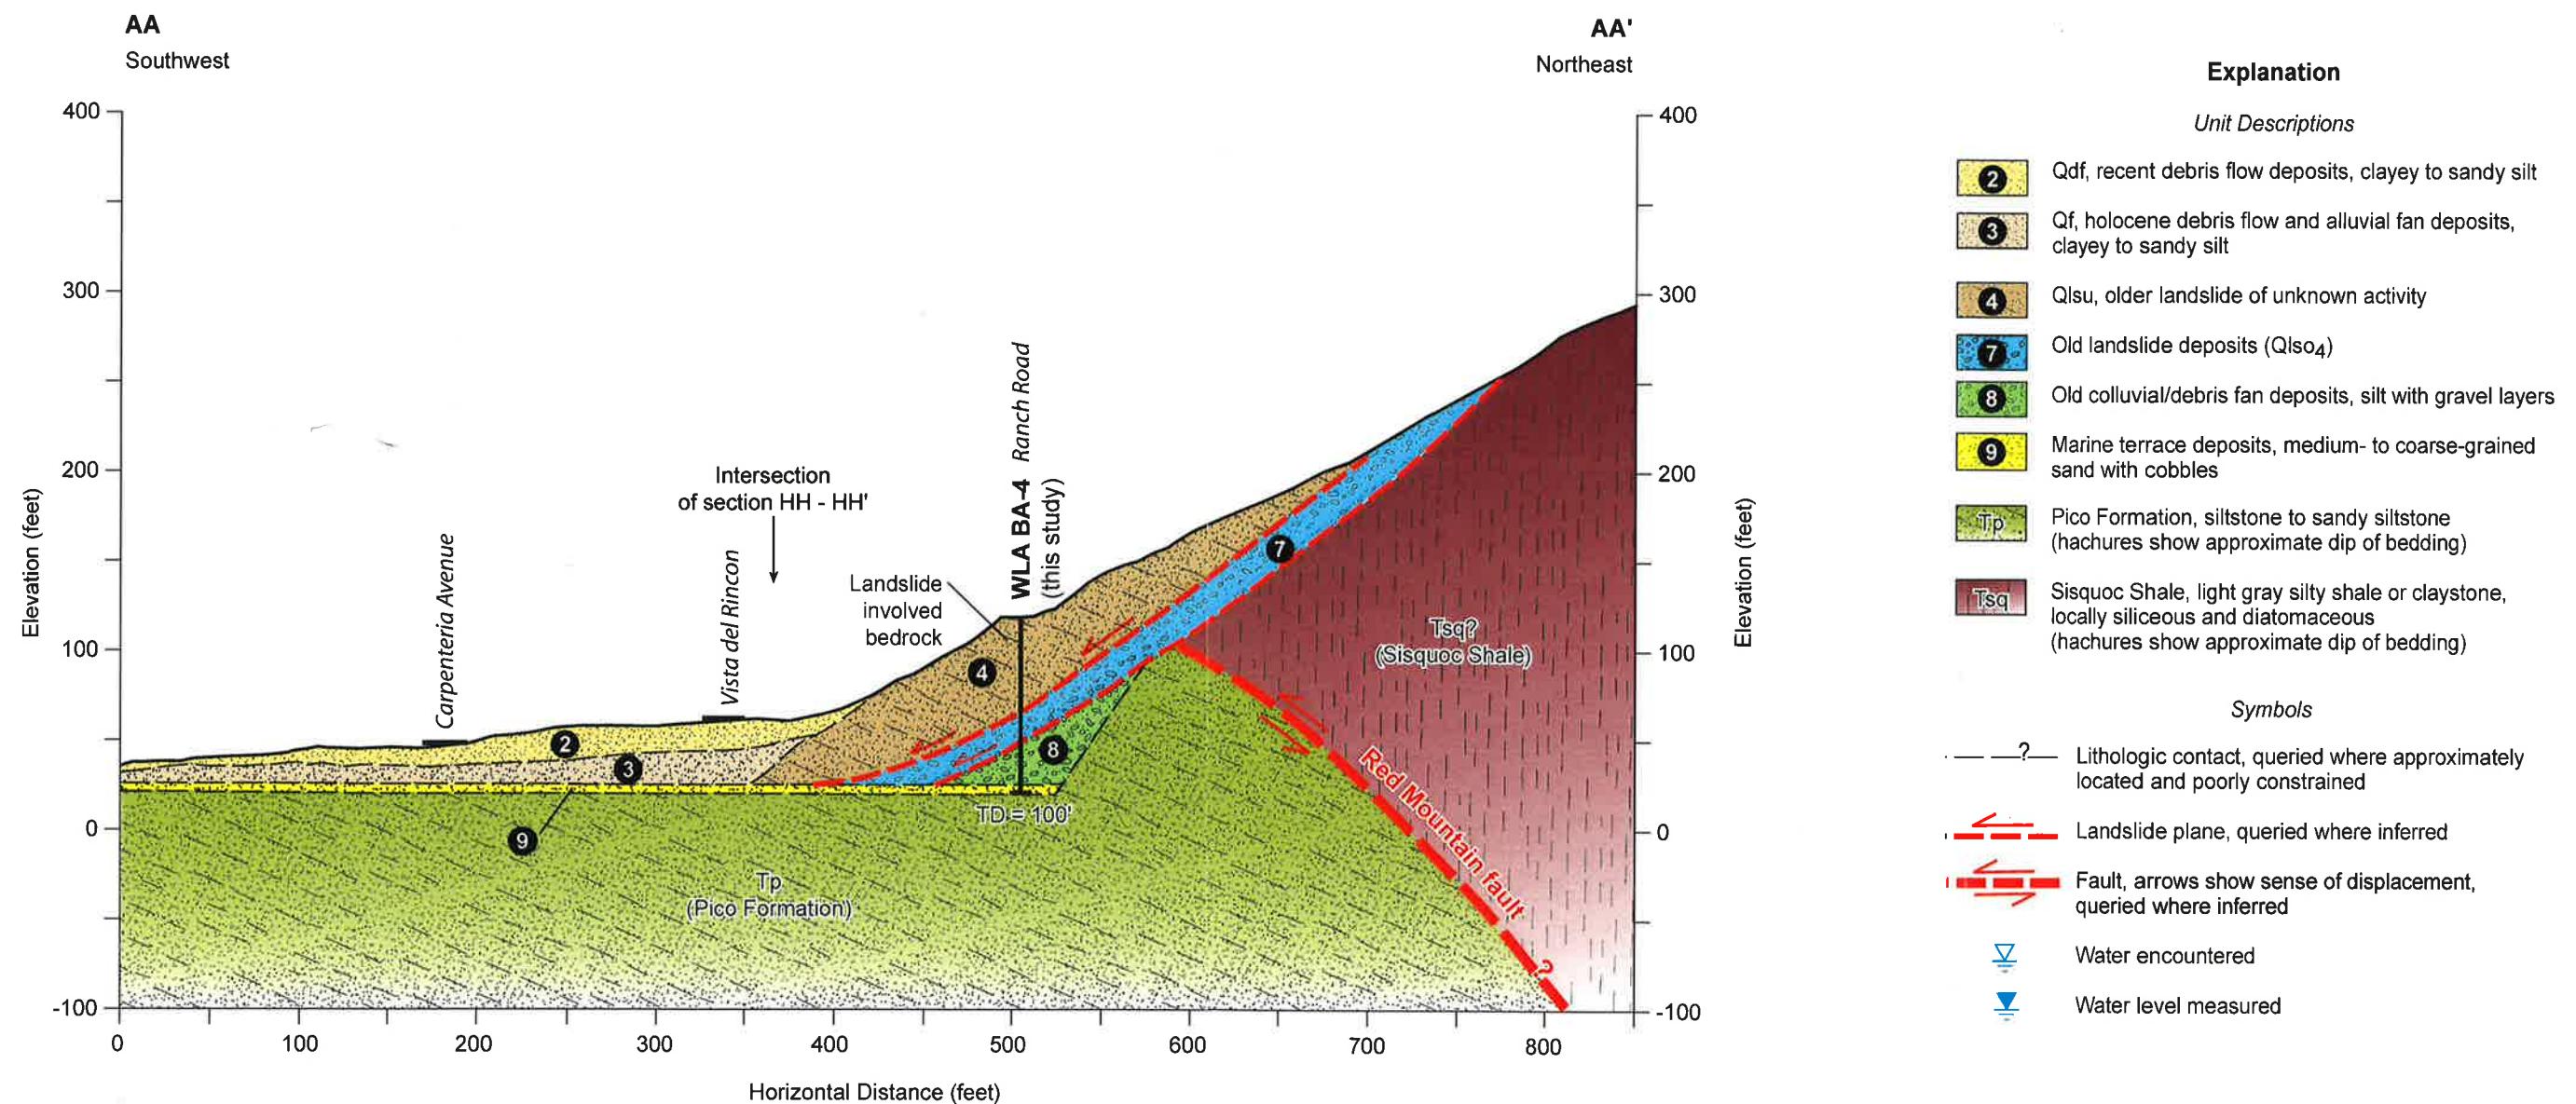
WLA	WILLIAM LETTIS & ASSOCIATES, Inc.
Figure B-2

LA CONCHITA	
Geologic Cross Section AA - AA'

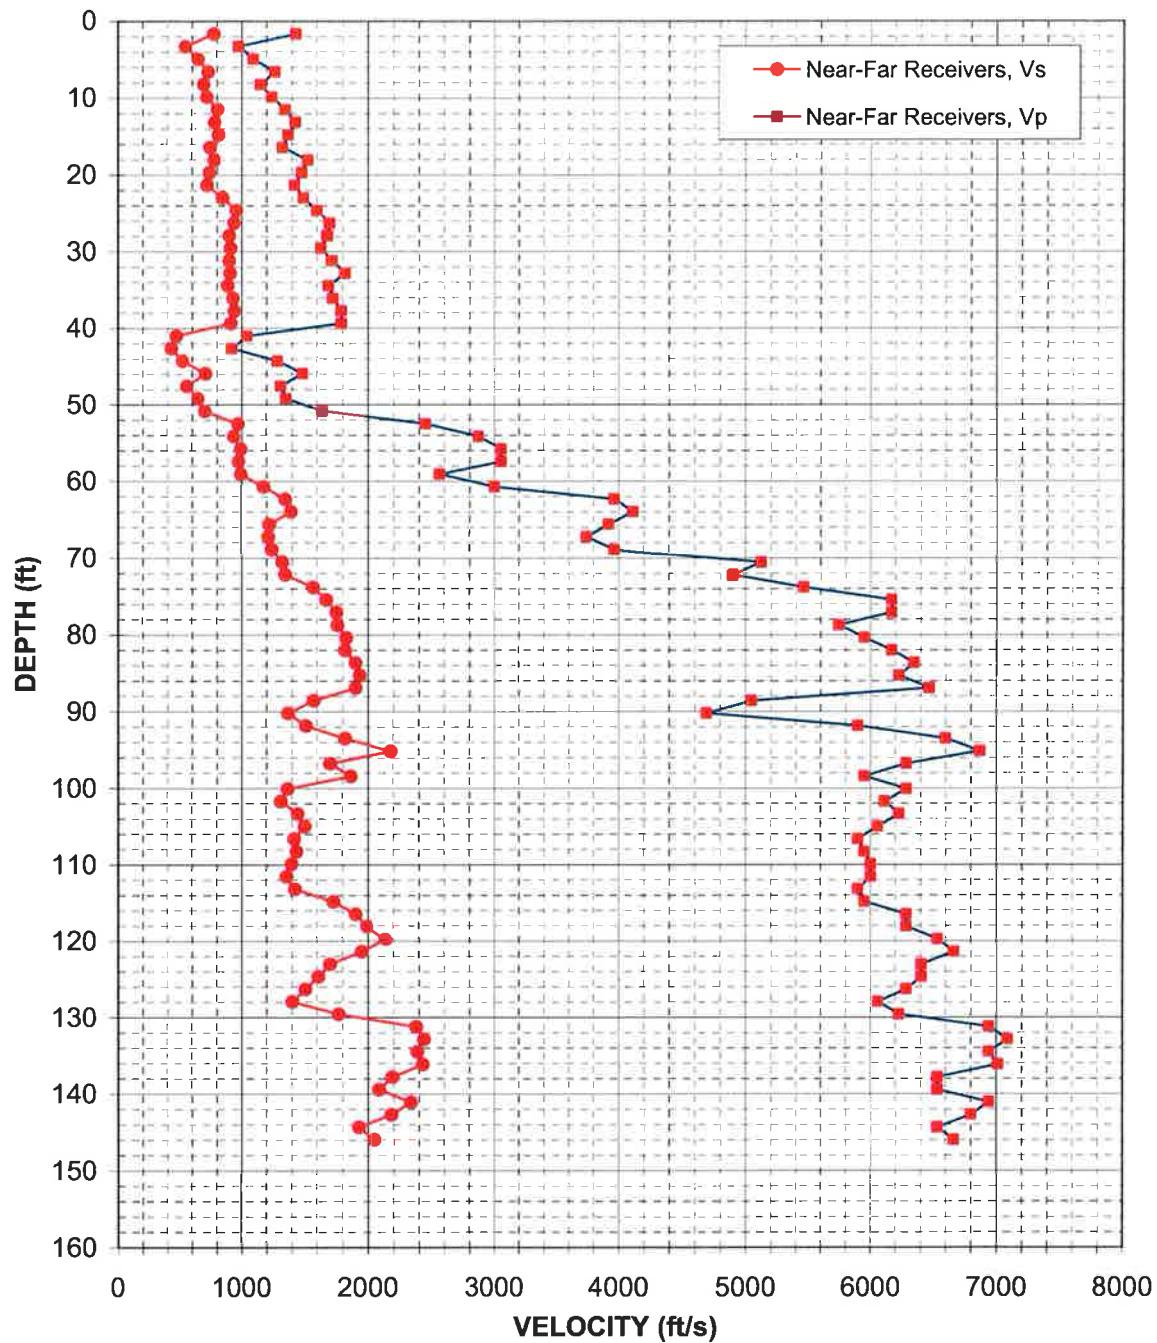
Figure 4: Boring B-1, Suspension R1-R2 P- and S_H -wave velocities

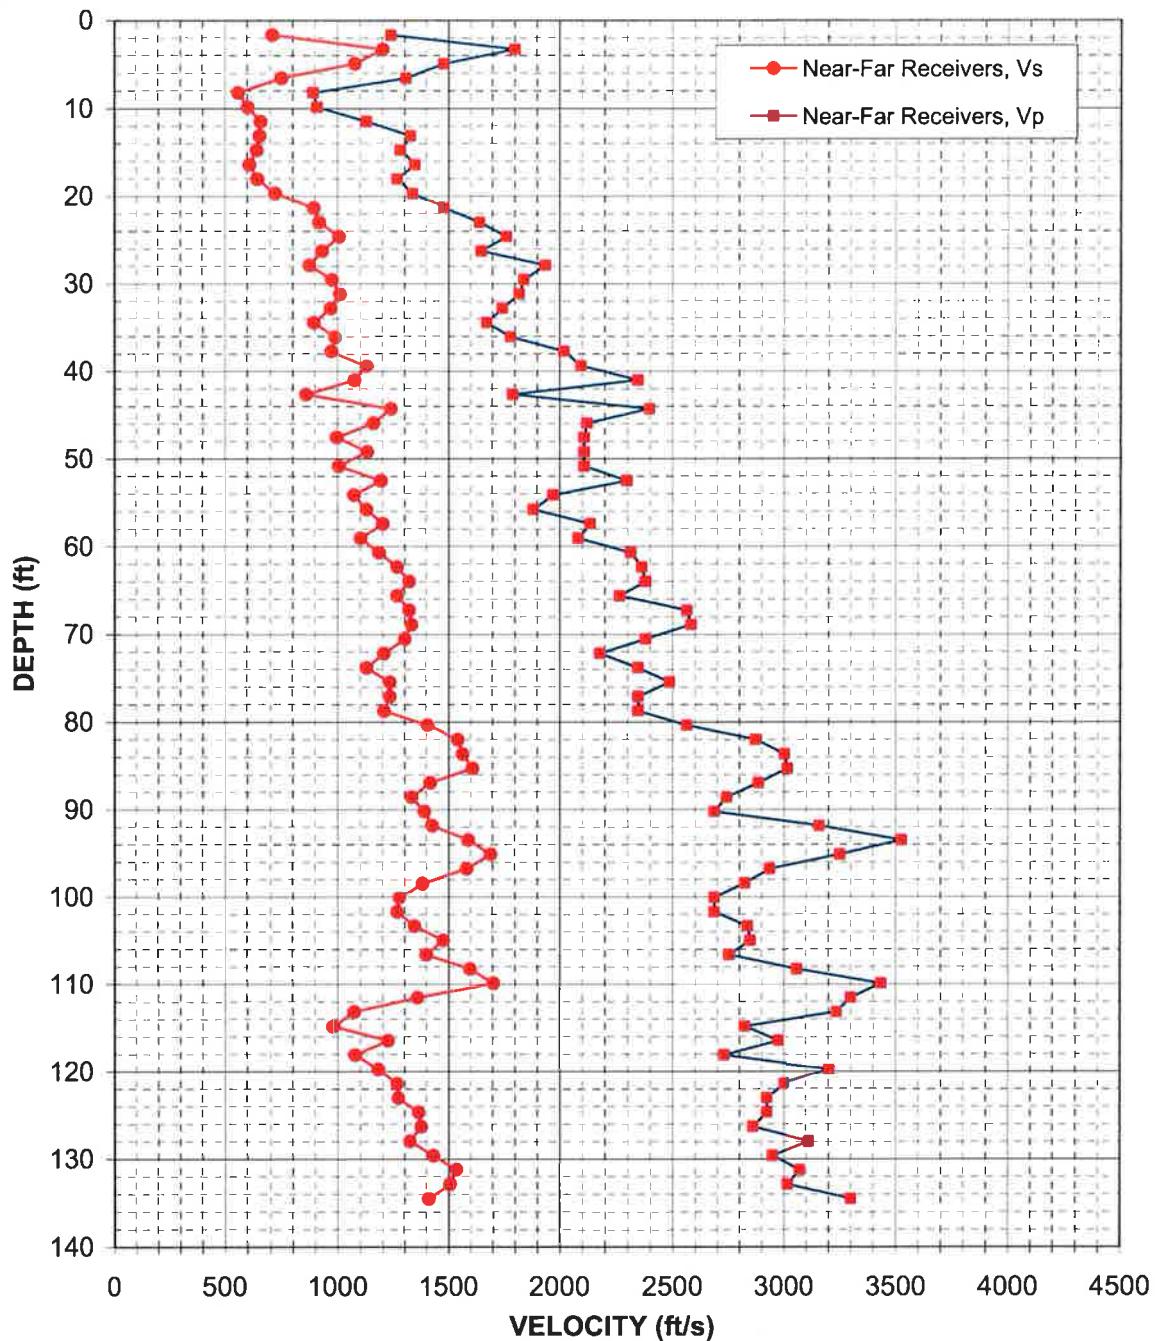
Figure 5: Boring B-2, Suspension R1-R2 P- and S_H -wave velocities

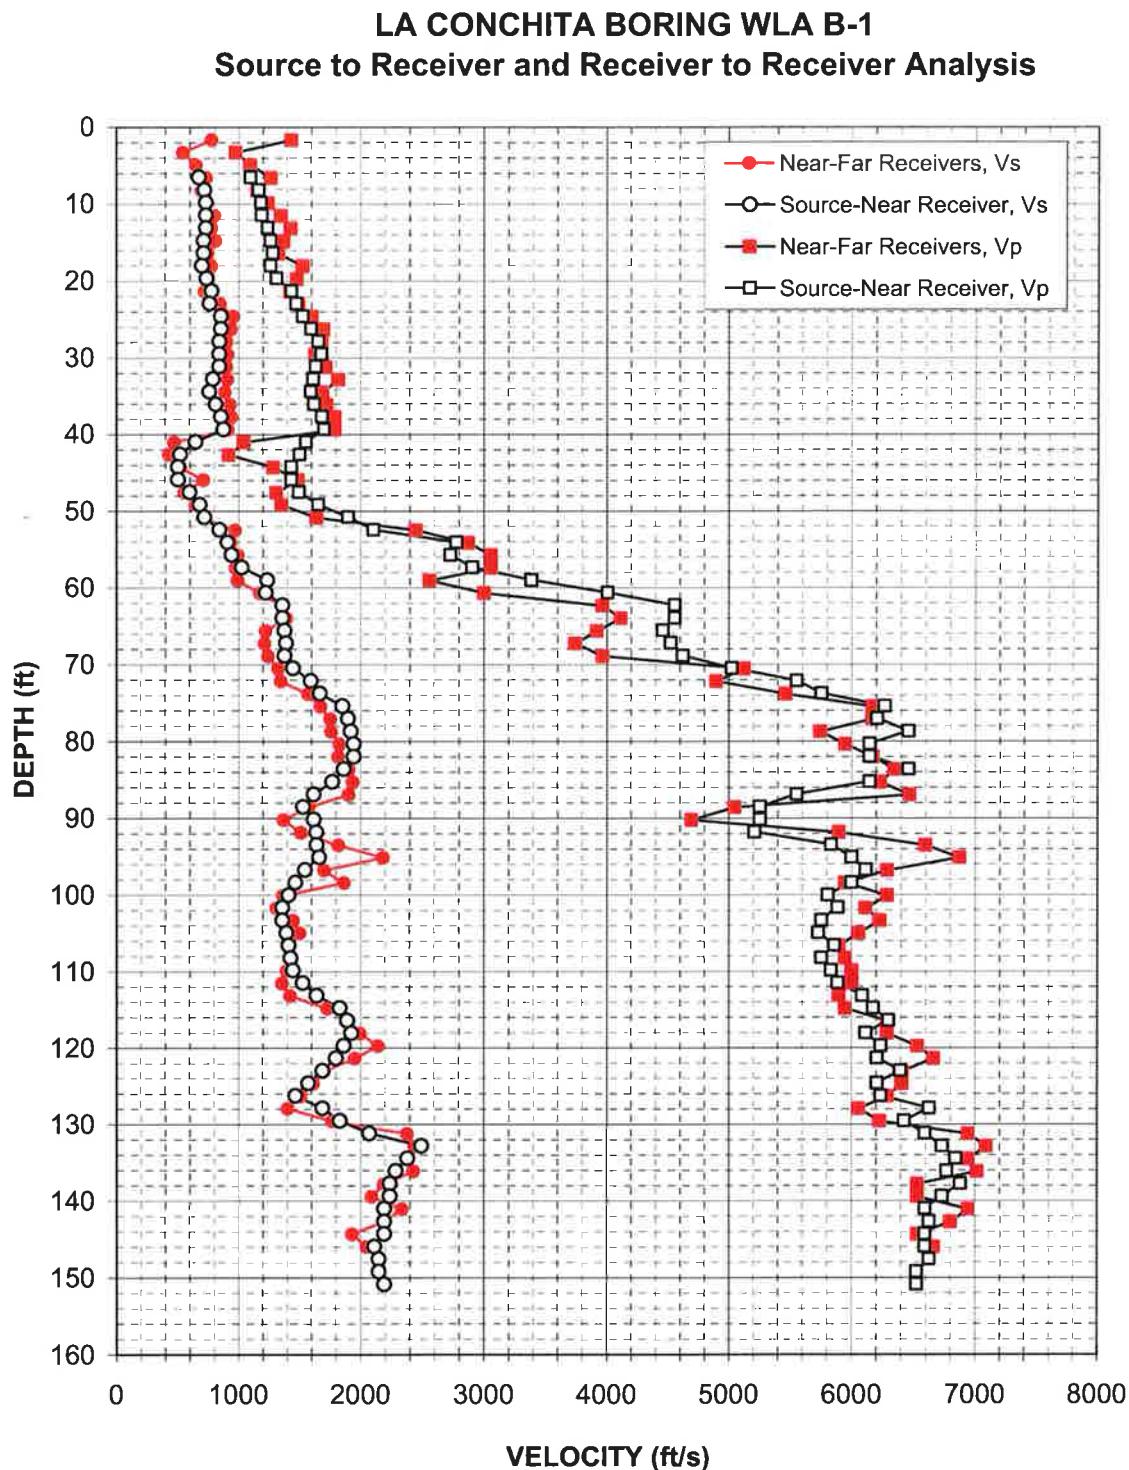
Figure A-1: Boring B-1, Suspension S-R1 P- and S_H-wave velocities

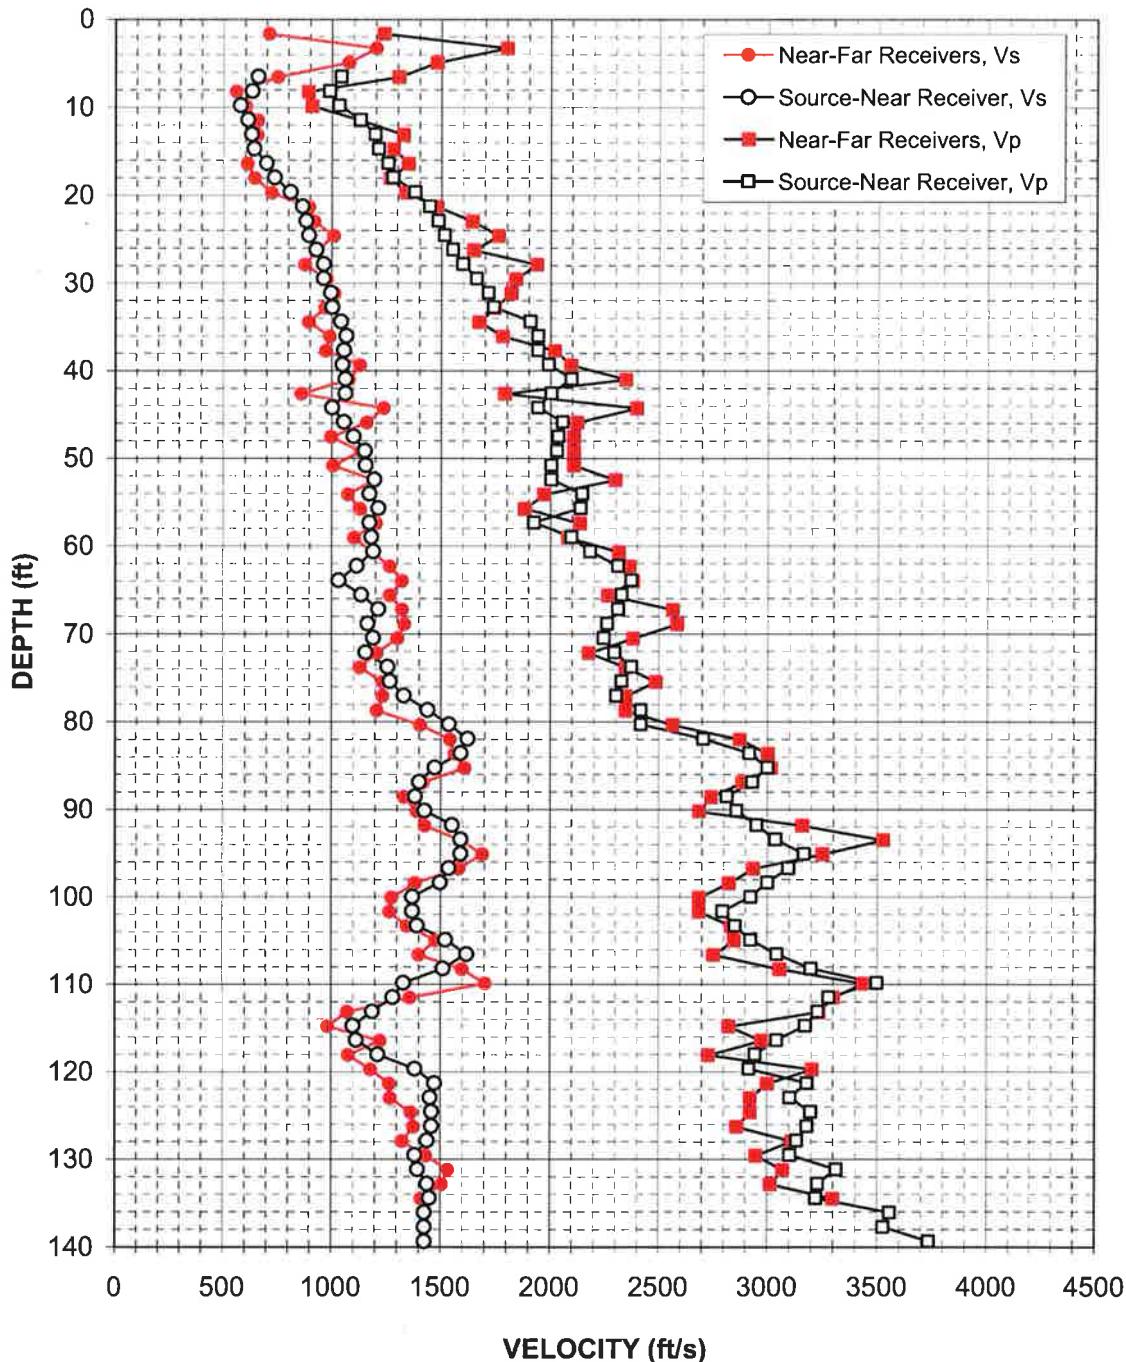
Figure A-2: Boring B-2, Suspension S-R1 P- and S_H -wave velocities
